NOTICE TO MARINERS

№8 - 2019

HARBOUR AND PORT OF MANCHESTER

PILOT LADDERS

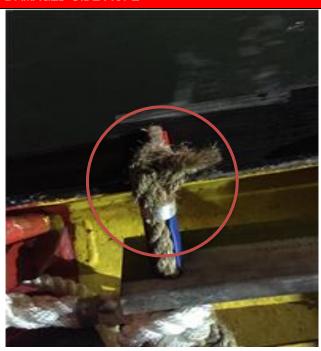
DAMAGED SIDE ROPE

This example shows a poorly maintained pilot ladder.

Should this side rope part, the ladder will undoubtedly fall.

All elements of the pilot ladders must be maintained as per SOLAS V23.

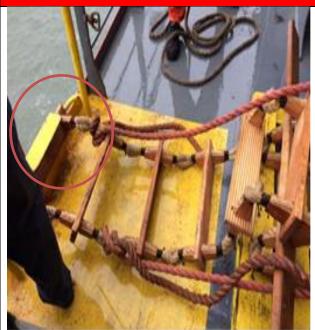
RUNG BRACED AGAINST DECK PLATE/GUARD

This example shows a rung braced against a deck plate/guard. There is evidence of the side ropes being secured by extra lines, but these lines are unbalanced and slack.

The rung is not designed to bear the weight of the pilot ladder, and it is doubtful that the deck guard is either, creating risk of the ladder dropping.

The ladder should be of a sufficient length to be able to secure the side ropes so that the tail ends/hard eye can be made fast.

If this is impracticable, the side ropes on either side of the ladder should be secured to a strong point with separate adequate lines, using a rolling hitch, equally spaced and the weight of the ladder should be on these lines.

The weight of the ladder should not rest on the on a deck guard.
