## NOTICE TO MARINERS

**No.7 – 2018**

**PORT OF HEYSHAM**

### **PILOT BOARDING ARRANGEMENTS**

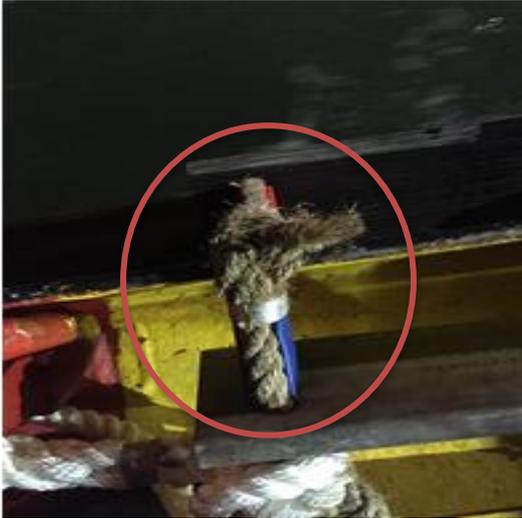
### Damaged side rope

This example shows a poorly maintained pilot ladder.

Should this side rope part, the ladder will undoubtedly fall.

All elements of the pilot ladders must be maintained as per SOLAS V23.

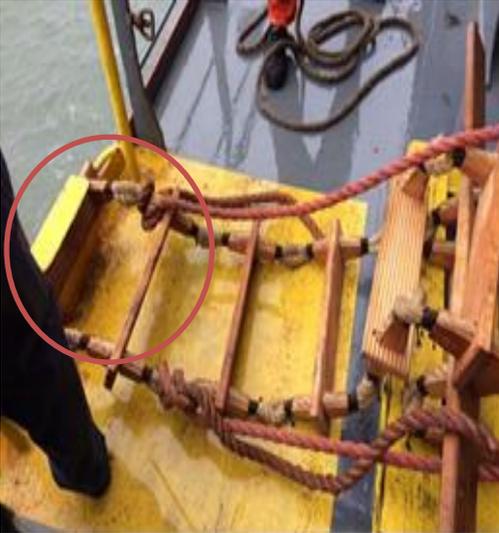
### Rung braced against deck plate/guard

This example shows a rung braced against a “deck plate/guard”. There is evidence of the side ropes being secured by extra lines, but these lines are unbalanced and slack.

The rung is not designed to bear the weight of the pilot ladder and it is doubtful that the deck guard is, creating risk of the ladder dropping.

Best practice is for the ladder to be of a sufficient length to ensure the tail ends/hard eye are made fast to strong deck points.

If this is not reasonably practicable during risk assessment, determine whether the side ropes on either side of the ladder can be adequately secured to strong deck points with separate lines - using a rolling hitch, equally spaced and the weight of the ladder on these lines. This combined with shackles onto the side ropes into a rung, only as secondary mitigation.

The weight of the ladder should not rest on a deck guard

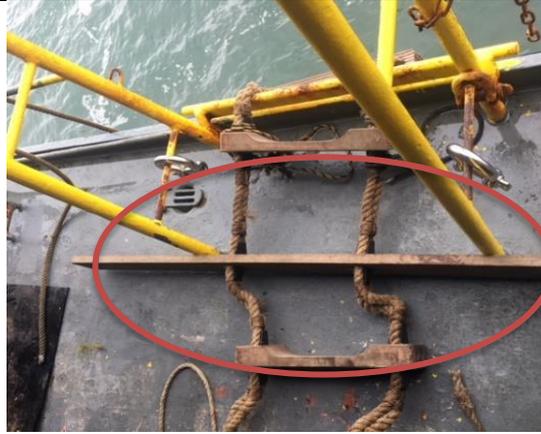
### Spreader braced against stanchion

This example shows the completely unacceptable practice of bracing a spreader against the stanchion of the handrail.

The spreader is not designed to bear the weight of the pilot ladder and there is no evidence of secondary securing.

The side rope itself must be secured to a deck strong point using the aforementioned methods.

The weight of the ladder should not rest on the spreader.

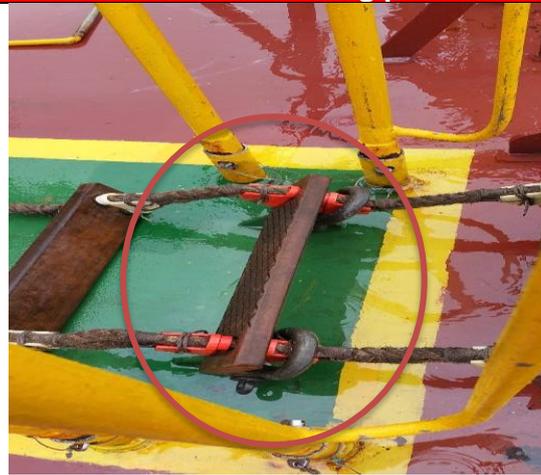
### Shackle secured to strong point but braced against rung.

This example shows shackles braced against one of the rungs.

Ladder rungs are only seized onto the side rope, so should the rung, whipping or rung wedges fail, the ladder will drop, at least until the next rung.

The side ropes on either side of the ladder should be secured to a strong point using the aforementioned methods.

The weight of the ladder should not rest on the shackle, on the rung.

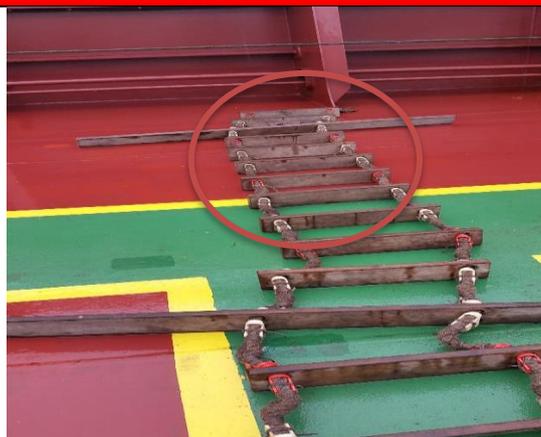
### Ladder unsecured at end

This example was in conjunction with the shackles onto a rung highlighted above.

If the securing method fails, the entire ladder may move across the deck and injure personnel.

Regardless of any other securing methods mentioned above, the side ropes should themselves always be secured to deck strong points at the tail ends/hard eye.
