Peel Ports Group

Medway Maintenance Dredge Protocol (MDP) Baseline Document

Update

July 2022

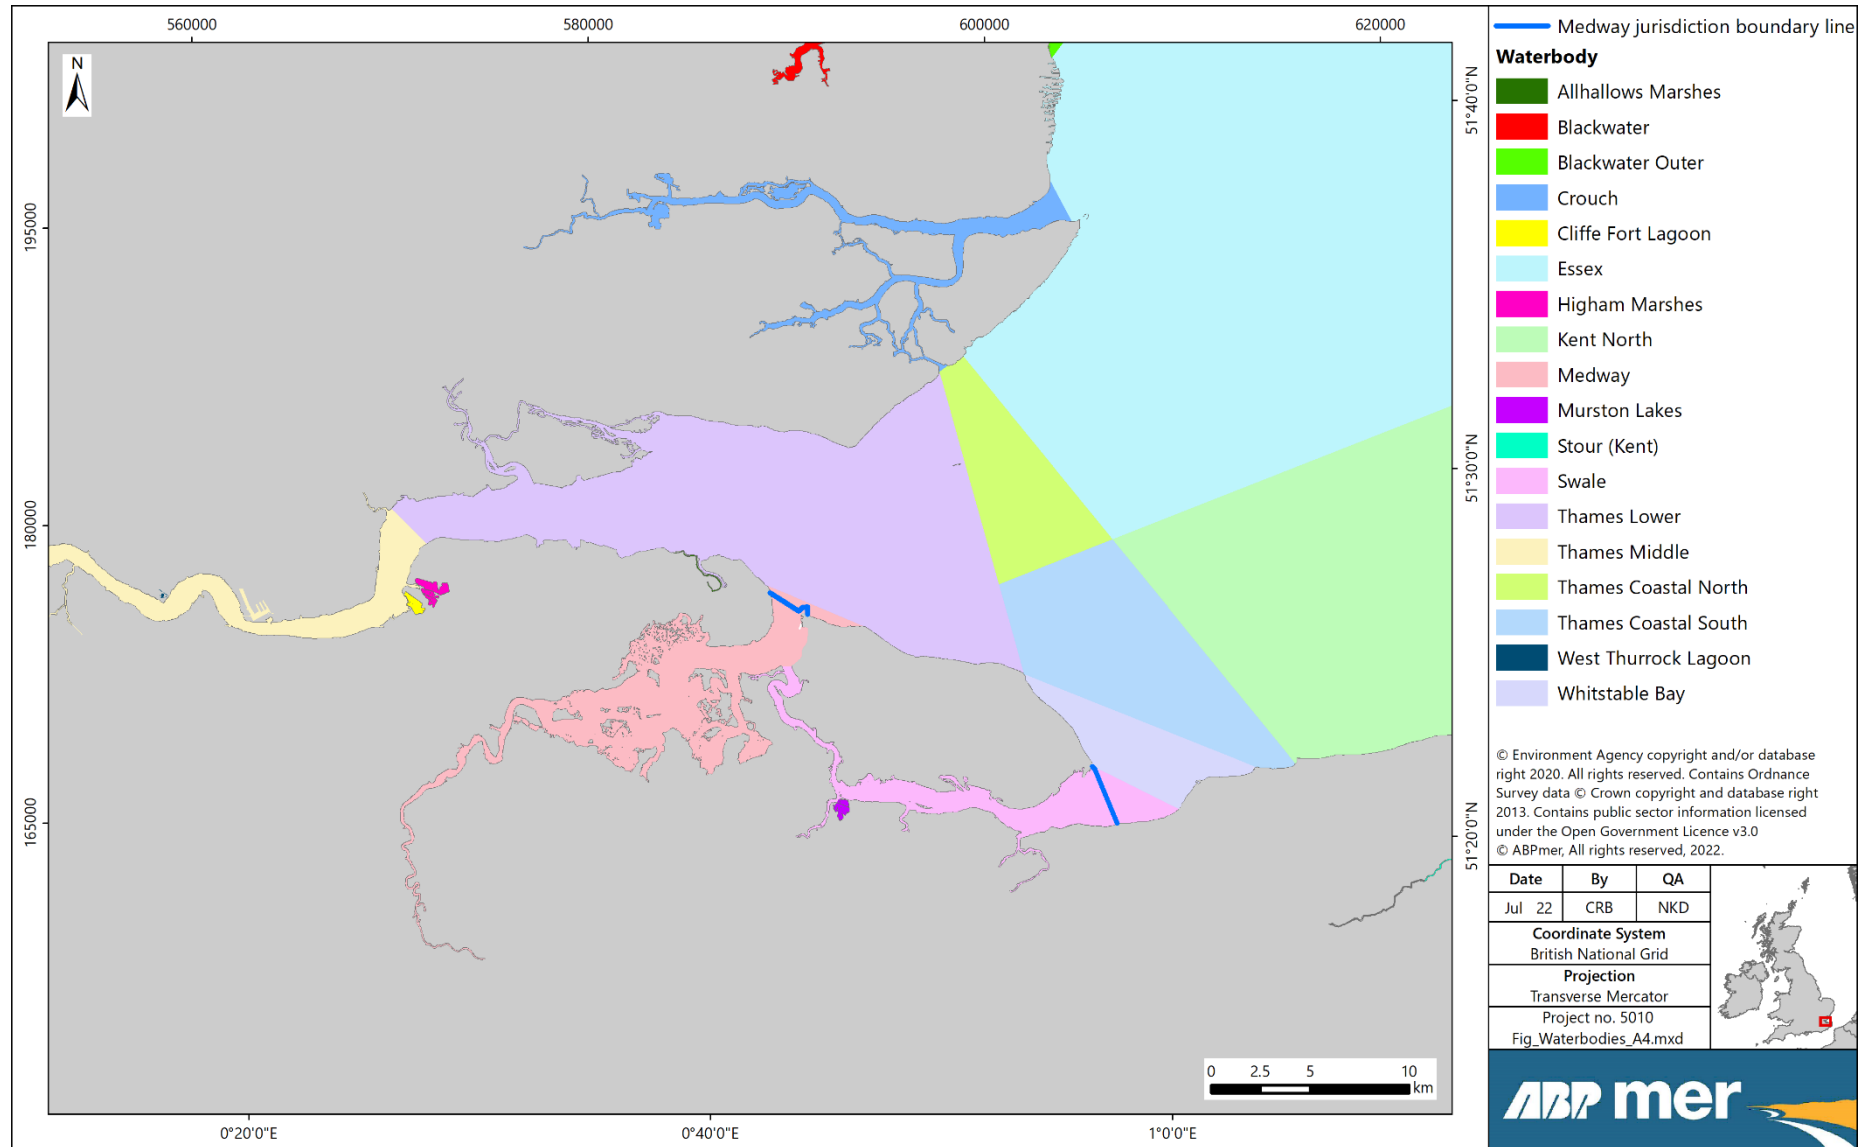
Figure 2.1 Transitional and coastal water bodies in study area

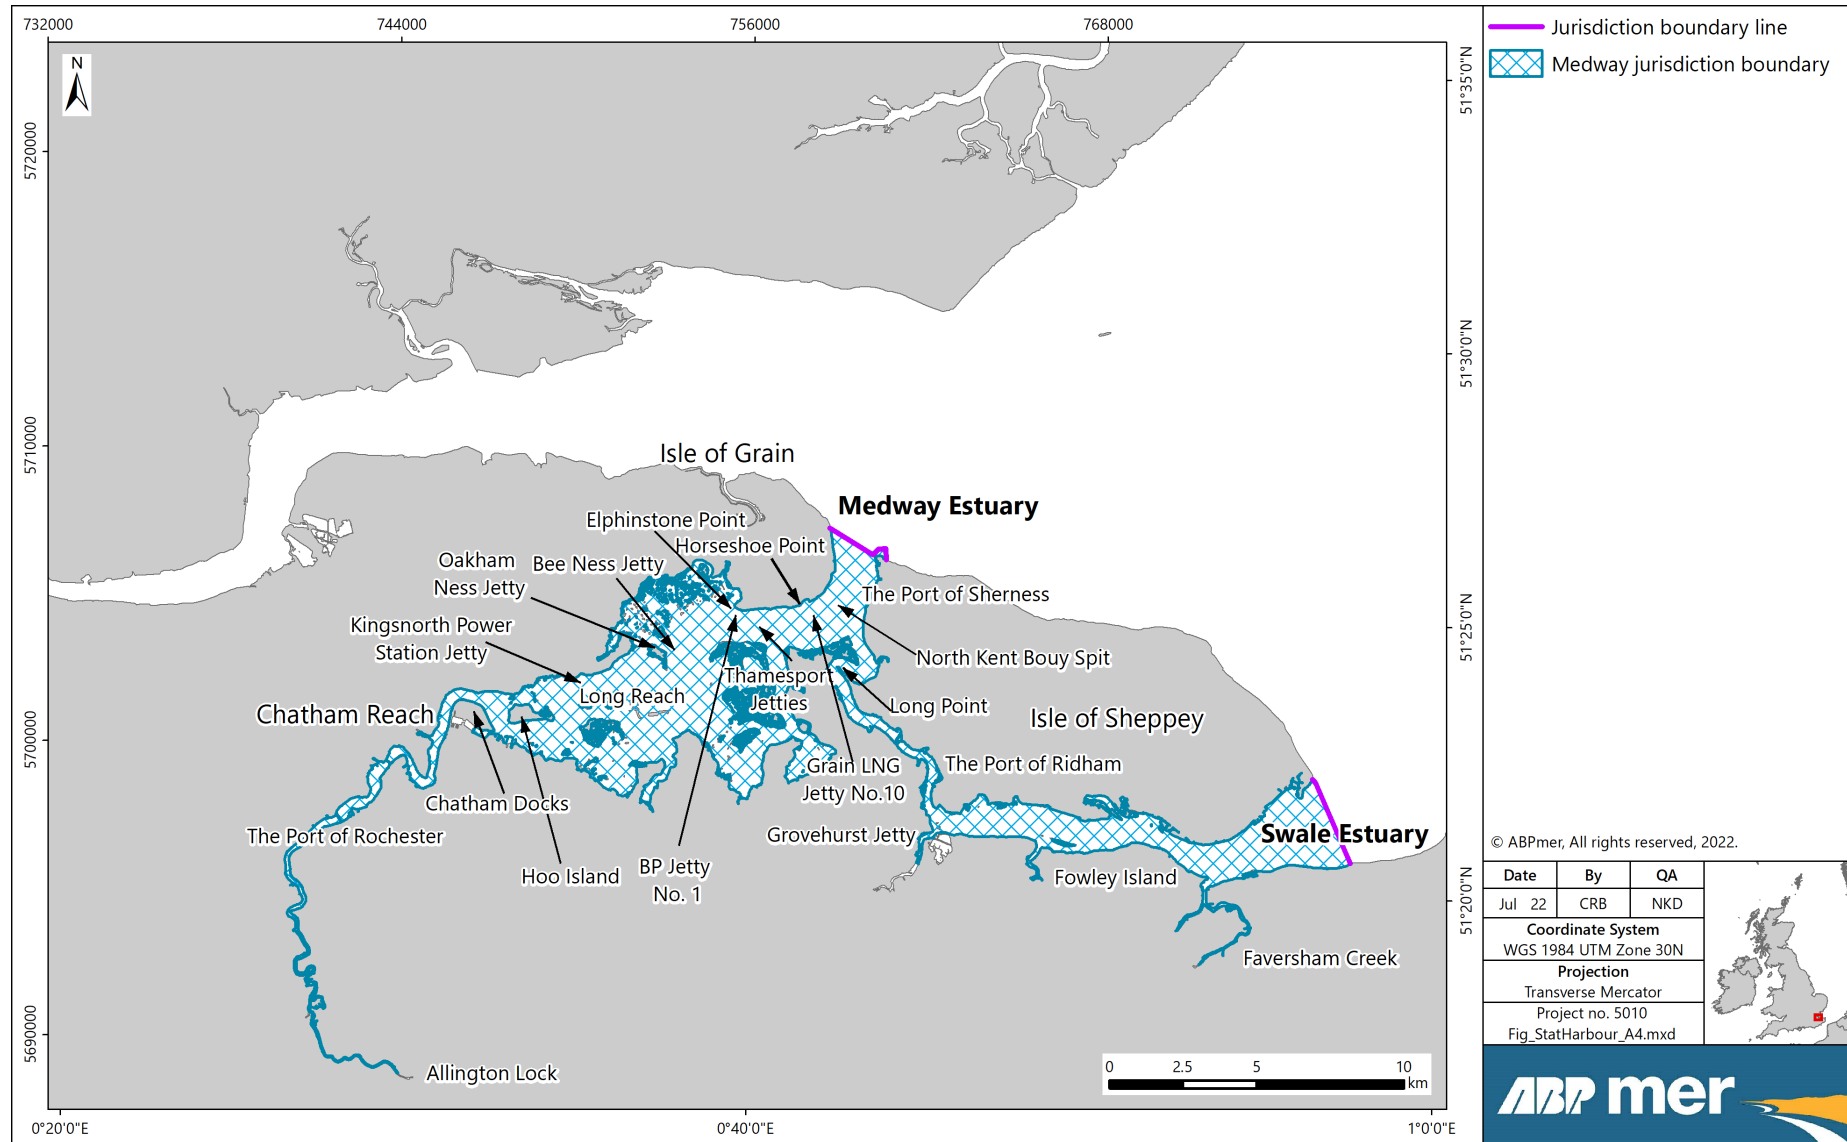
Figure 2.2 Statutory Harbour Authority area within the Medway

As the SHA, Peel Ports Medway, is responsible for maintaining safe port access for both commercial and recreational maritime transport around the Medway. Figure 2.2 illustrates Peel Ports Medway's administrative boundary as the SHA. Sediment is constantly entering and departing the estuary, some of which settles in dredged channels, berthing pockets, the docks, marinas and jetties. Dredging is therefore required to remove recently deposited sediment.

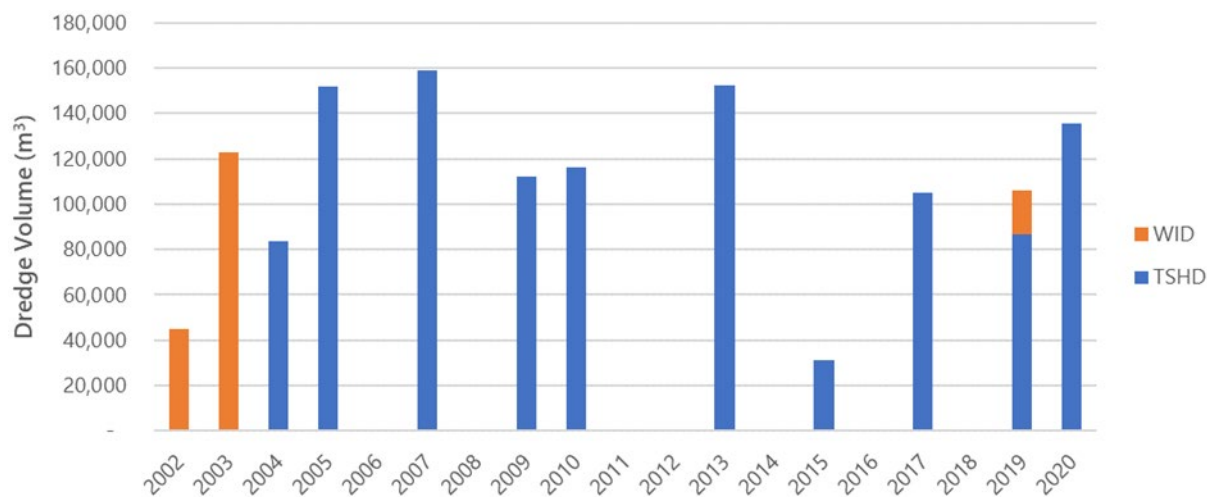
Figure 4.5 Dredge volumes for the Medway Approach Channel

Annual dredge volumes for the Medway Approach Channel using TSHD and/or WID over the period 2002 to 2020 inclusive are provided in Figure 4.5.

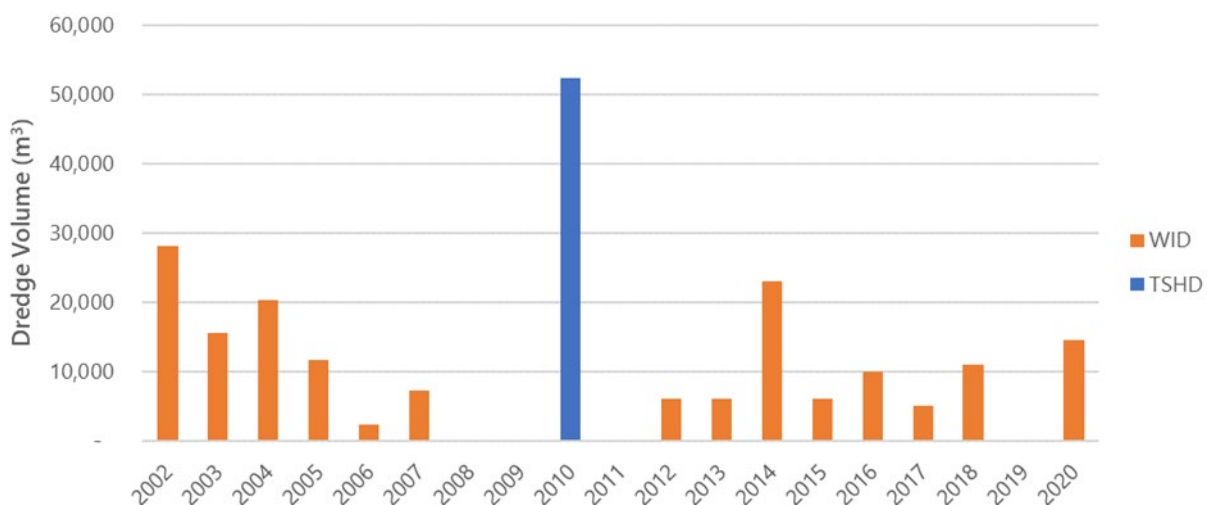
Figure 4.7 Dredge volumes for the Chatham Lock Approaches

Historically, approximately every 10 years, the area is dredged by a small TSHD which is usually a 5-day campaign, with the dredge arisings taken to the Hoo Island licensed land-based disposal site. There is no requirement to apply for a marine licence for dredged materials removed by TSHD under Harbour Authority powers which are then subsequently taken to land, as no deposit is made within the sea. Material placed on land is controlled under the Environment Agency Environmental Permitting arrangements. However, it should be noted that TSHD of the approaches with disposal to Hoo Island has only been carried out once since 2002; this occurred in 2010 (52,276 m³).

Annual dredge volumes for the Chatham Lock Approaches using TSHD (supported by plough dredging) or WID over the period 2002 to 2020 inclusive are provided in Figure 4.7.

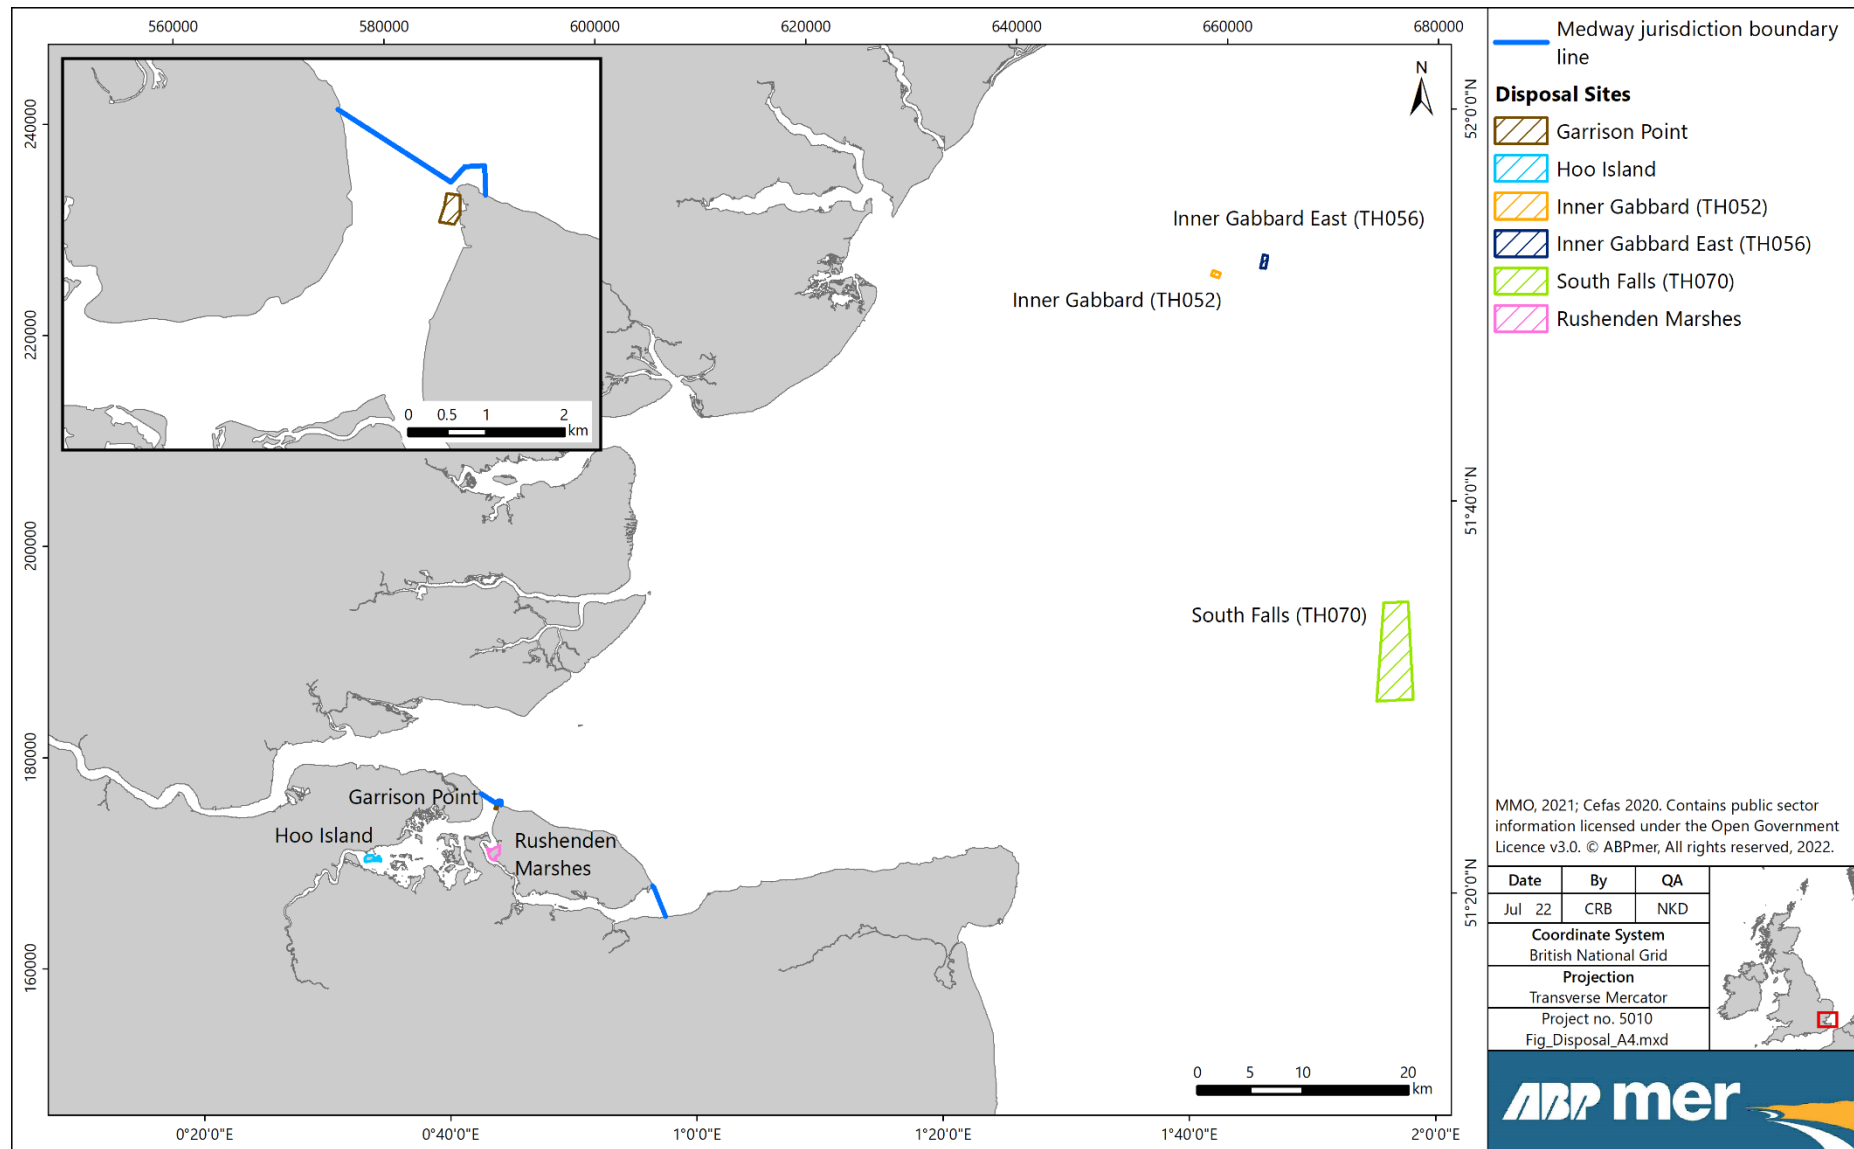
Figure 4.9 Dredge disposal sites

Peel Ports Medway currently operate two land-based dredge disposal facilities within the Medway; the first at Hoo Island and the second at Rushenden Marshes (see Figure 4.9). Both sites are designed to receive and handle dredged material associated with the maintenance of navigation dredging. In addition, the Hoo Island site also accepts material from terrestrial sources for engineering purposes (such as maintaining internal bunds). It should be noted that Peel Ports Medway have not disposed of dredge material to either of these land-based sites in recent years.

There are a number of licensed marine disposal sites within the Thames Estuary (Figure 4.9), with South Falls (TH070) and Inner Gabbard (TH052) the main sites used for maintenance dredge material. The Medway Approach Channel (TH101) and Garrison Point (TH103) licensed disposal sites have been used for capital dredge campaigns, but these sites are not used for maintenance dredging. The Medway Approach Channel site (TH101) is now closed; however, all other sites remain open, although Garrison Point (TH103) has not been used since the 2001 capital dredge campaign (i.e. disused). Table 4.4 and Figure 4.10 present disposal quantities released at the South Falls and Inner Gabbard licensed disposal sites from the Medway Approach Channel. Between 2002 and 2020 inclusive, the total quantity of dredge material (primarily sand) deposited at the South Falls and Inner Gabbard licensed disposal sites is 771,883 and 403,344 tonnes, respectively.

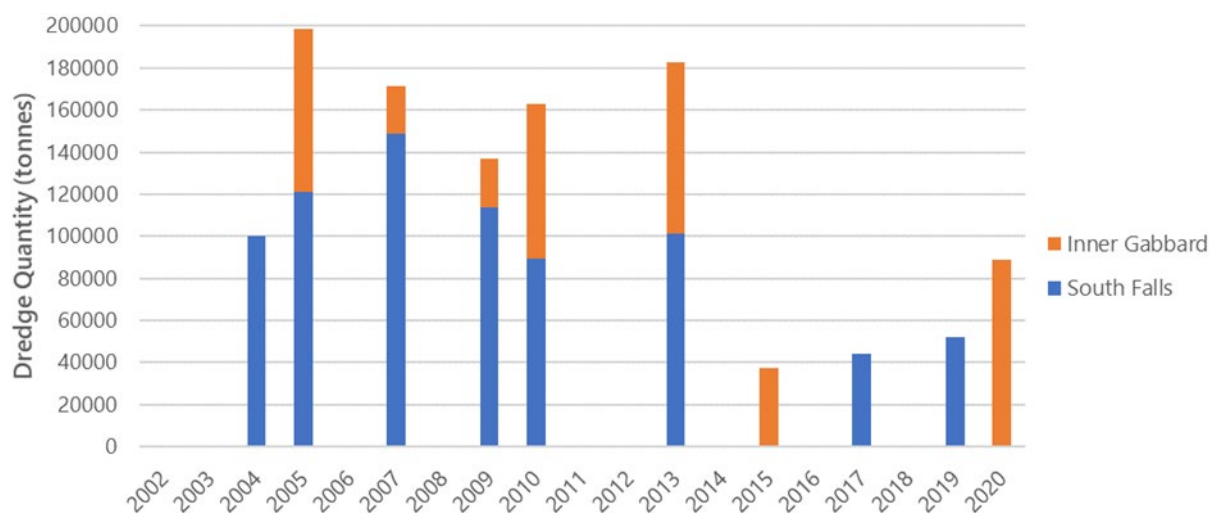
Figure 4.10 Maintenance dredge disposal quantities from the Medway Approach Channel deposited at licensed marine disposal sites

Year	Disposal Quantity (Tonnes)	
	South Falls (TH070)	Inner Gabbard (TH052)
2002*	0	0
2003*	0	0
2004	100,230	0
2005	121,335	77,409
2006	0	0
2007	148,875	22,579
2008	0	0
2009	113,982	22,641
2010	89,502	73,228
2011	0	0
2012	0	0
2013	101,397	81,118
2014	0	0
2015	0	37,400
2016	0	0
2017	44,208	0
2018	0	0
2019*	52,354	0
2020	0	88,969

* Note, WID used to dredge the Medway Approach Channel in 2002 and 2003; therefore, no deposits to a licensed marine disposal site in these two years. In 2019, while TSHD was primarily used to remove significant quantities of dredge material (which required disposal at sea), WID was also trialed within the Medway Approach Channel (19,363 m³).

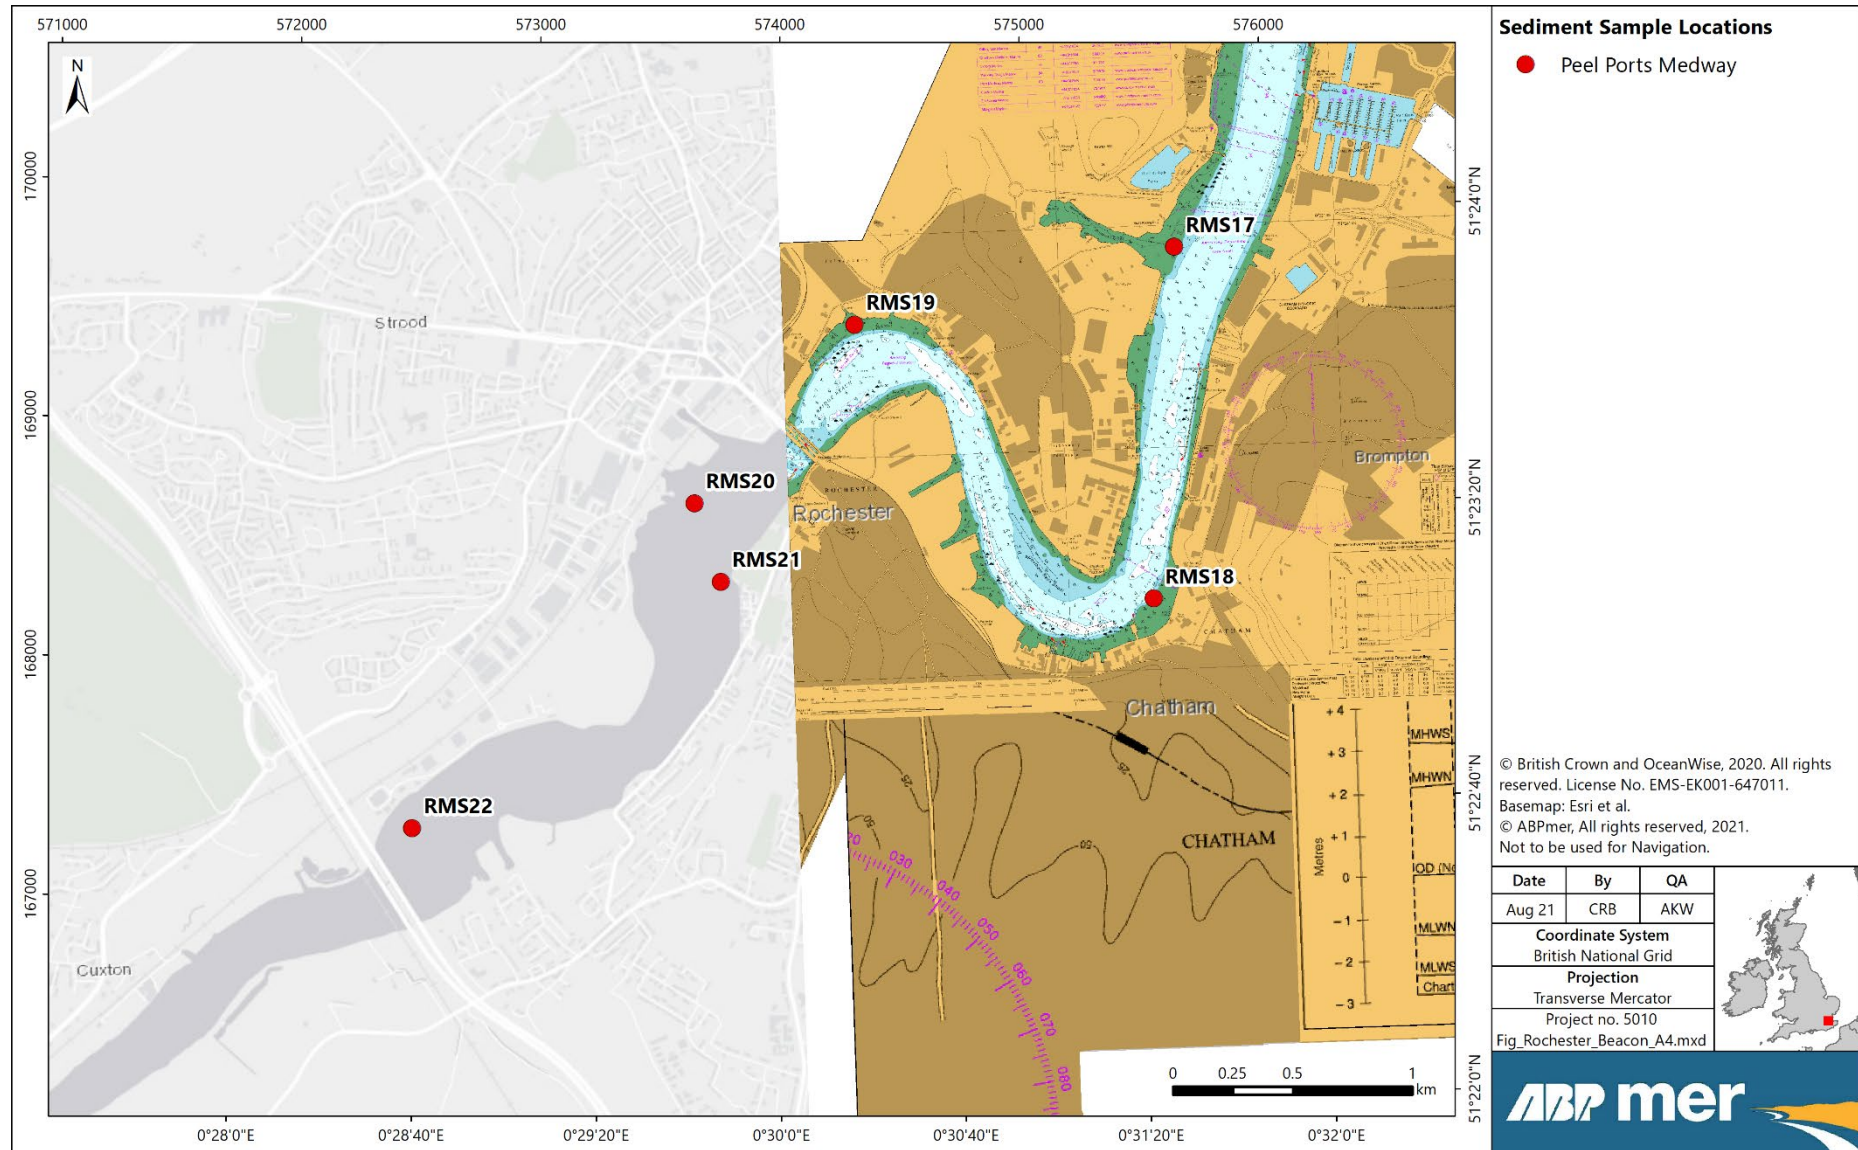
Figure 5.6 Sediment sample locations in the tidal River Medway

while Gillingham Marina obtained three samples in the same year. See Figure 5.5 and Figure 5.6 for individual sample locations.

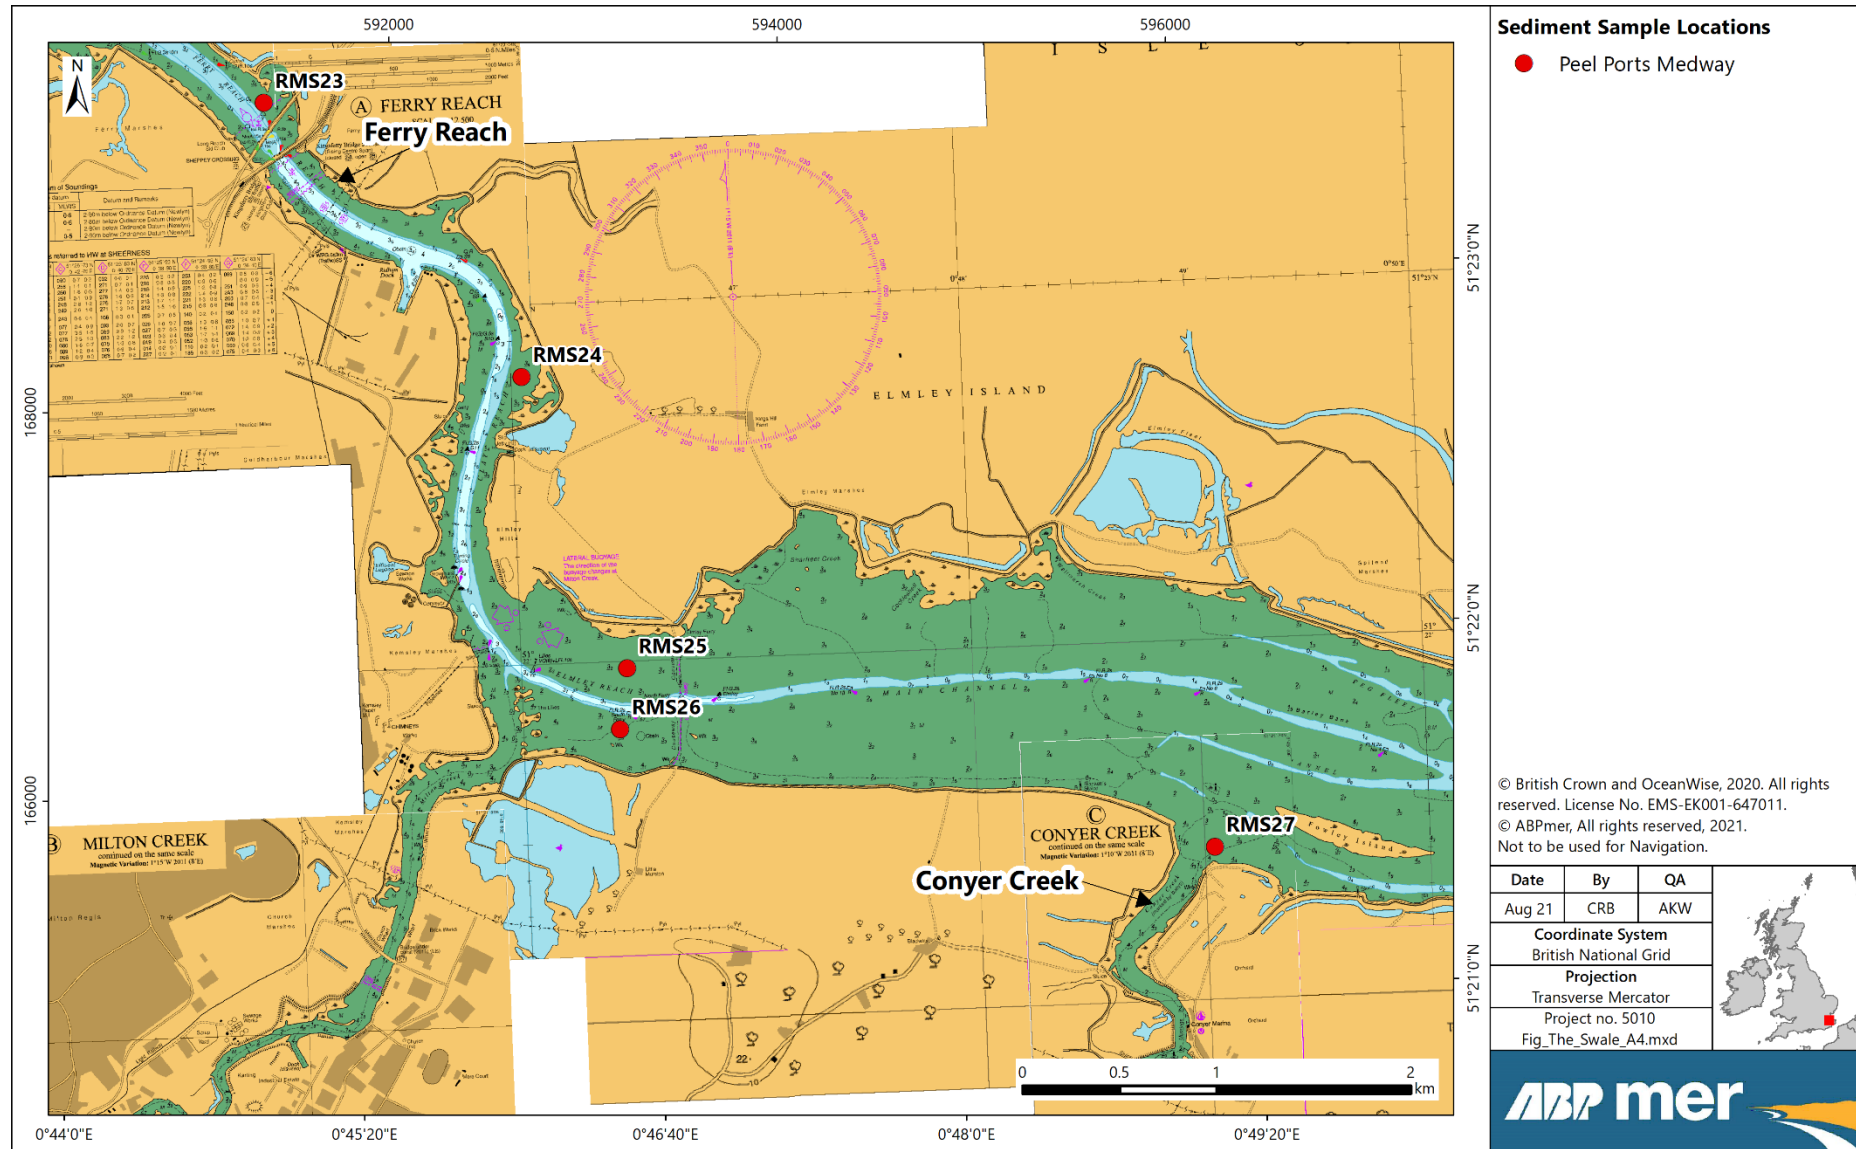
Figure 5.7 Sediment sample locations in The Swale

This area includes Ferry Reach on The Swale through to the entrance of Conyer Creek. Sediment quality data is available from Peel Ports Medway sampling in 2012 (RMS23 through to RMS27), as well as third party samples from the entrance to East Swale as part of the London Array cable route studies (LA1 and LA2). See Figure 5.7 and Figure 5.8 for sample locations.

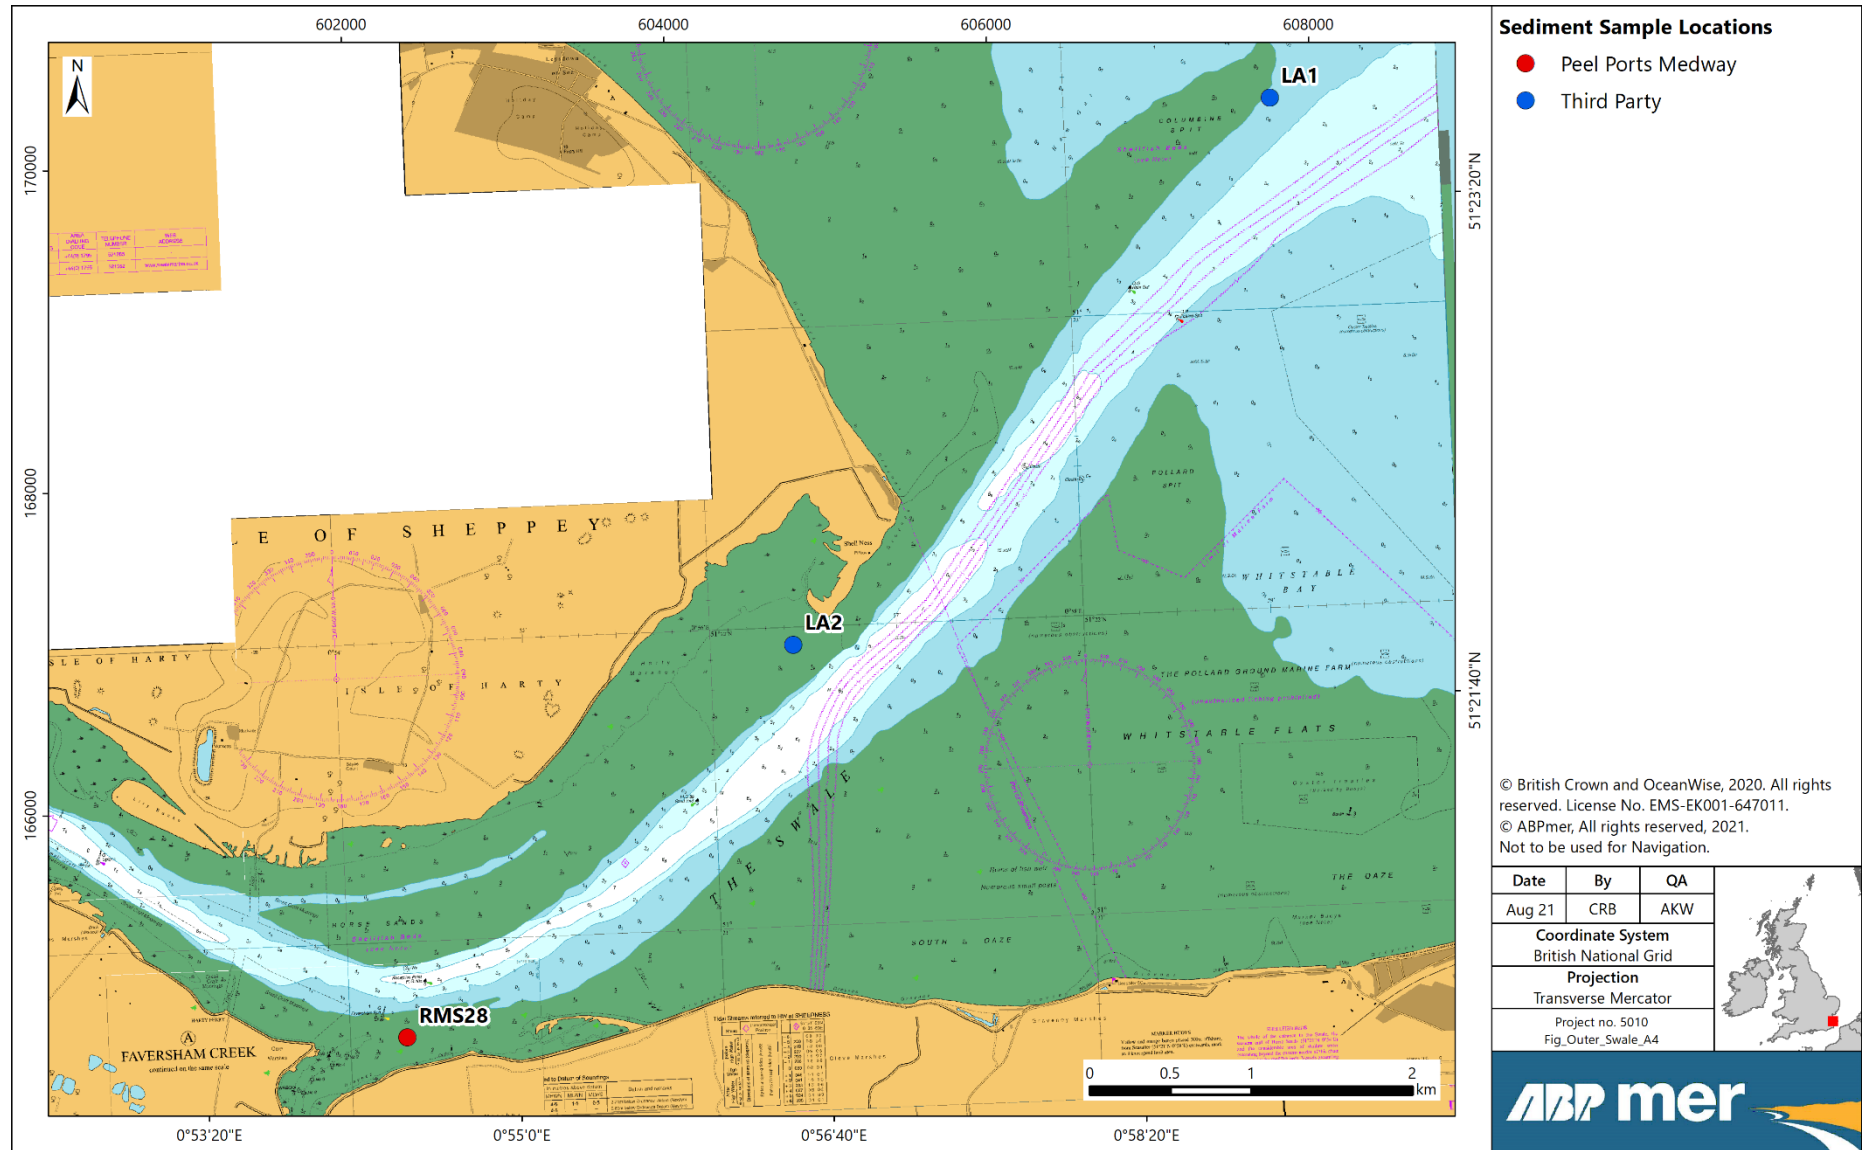
Figure 5.8 Sediment sample locations in The Swale (Outer)

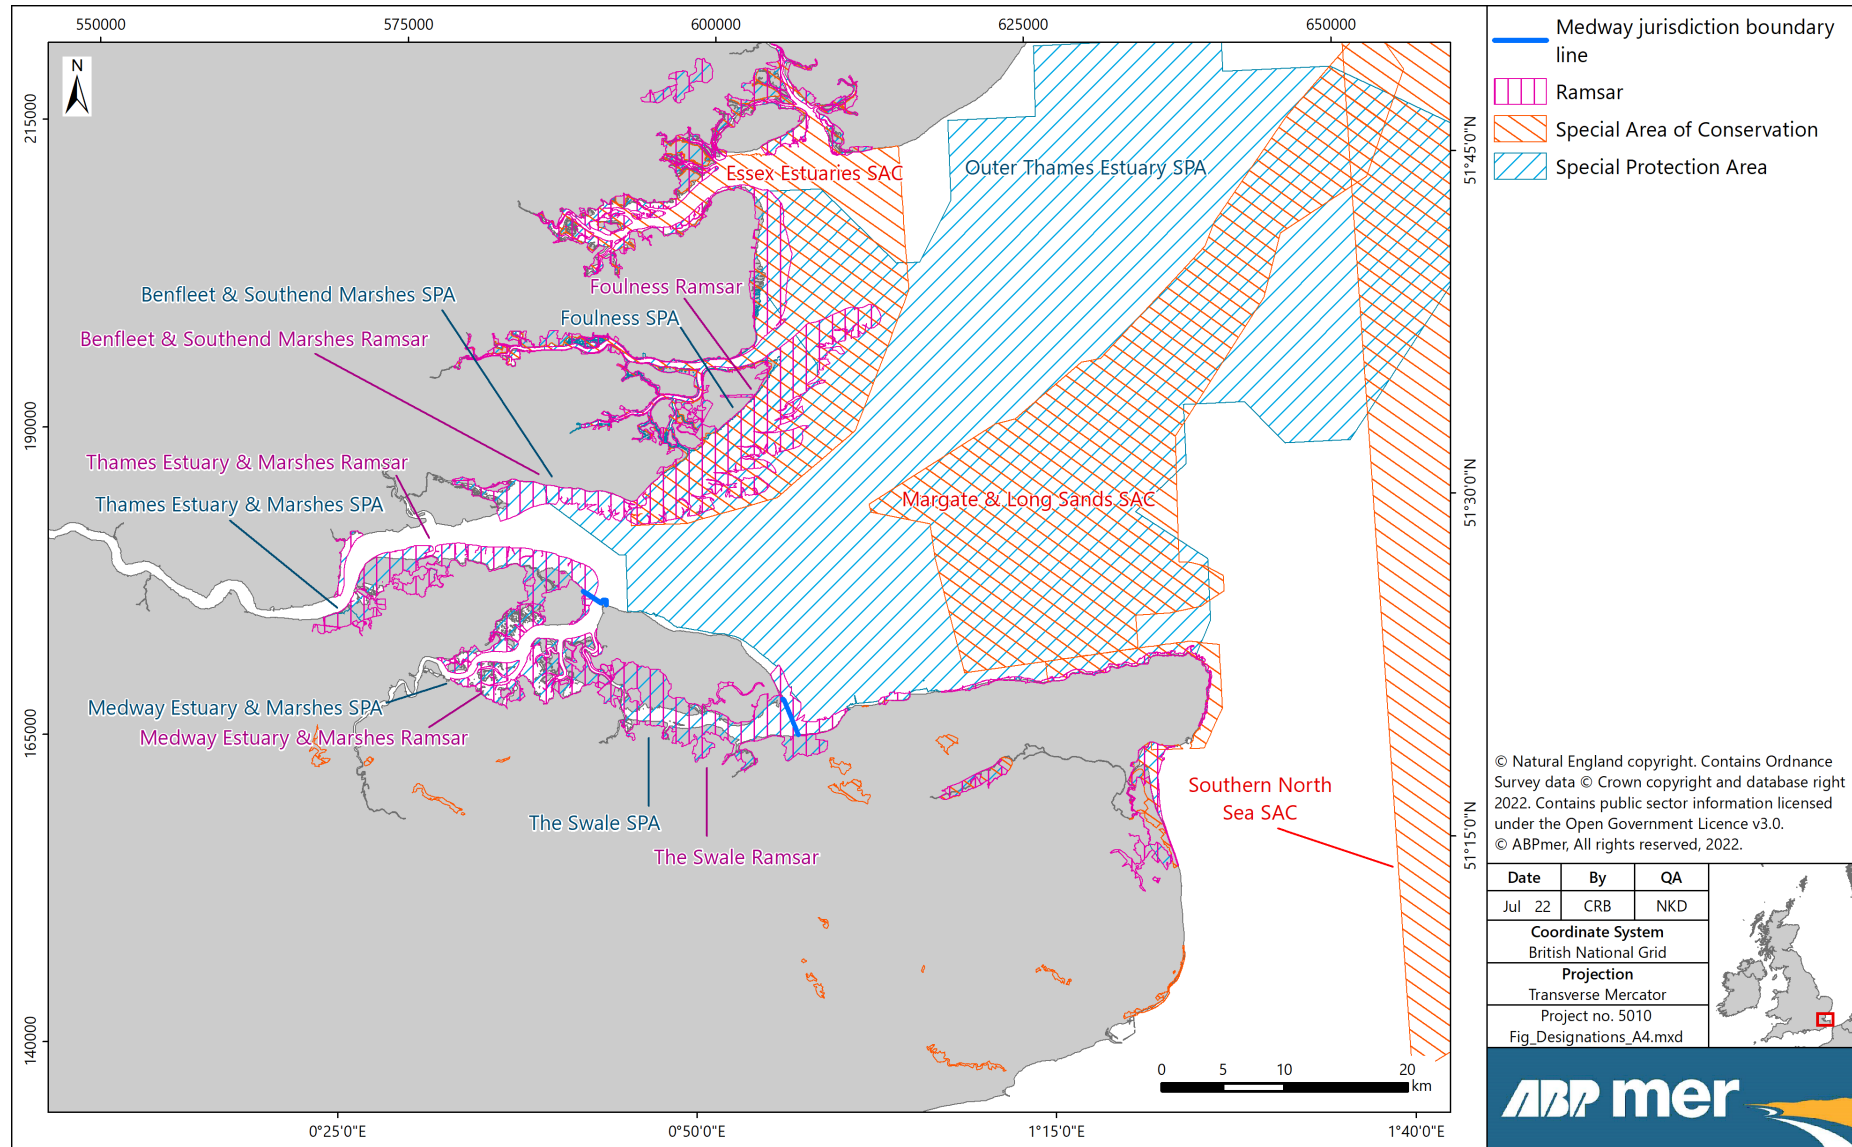
Figure 7.1 European and international nature conservation designated sites in the study area

The Birds Directive (2009/147/EC) requires all member states to identify areas to be given special protection for the rare or vulnerable species listed in Annex 1 of the Directive (Article 4.1), for regularly occurring migratory species (Article 4.2) and for the protection of wetlands, especially wetlands of international importance. This legislation has since been transposed into UK legislation by the Habitats Regulations. These areas are known as Special Protection Areas (SPAs) and those relevant to this Baseline Document include (see Figure 7.1):

The Habitats Directive (92/43/EEC) requires the establishment of a network of important high-quality conservation sites that will make a significant contribution to conserving habitat types and species identified in Annexes I and II of the Directive. There are three Special Areas of Conservation (SACs) within the study area of this Baseline Document, namely (see Figure 7.1):

Under the 1971 Ramsar Convention on Wetlands of International Importance, it is a requirement of signatory states to protect wetland sites of international importance, including those that are important waterfowl habitats. There are five Ramsar sites relevant to this Baseline Document including (see Figure 7.1):

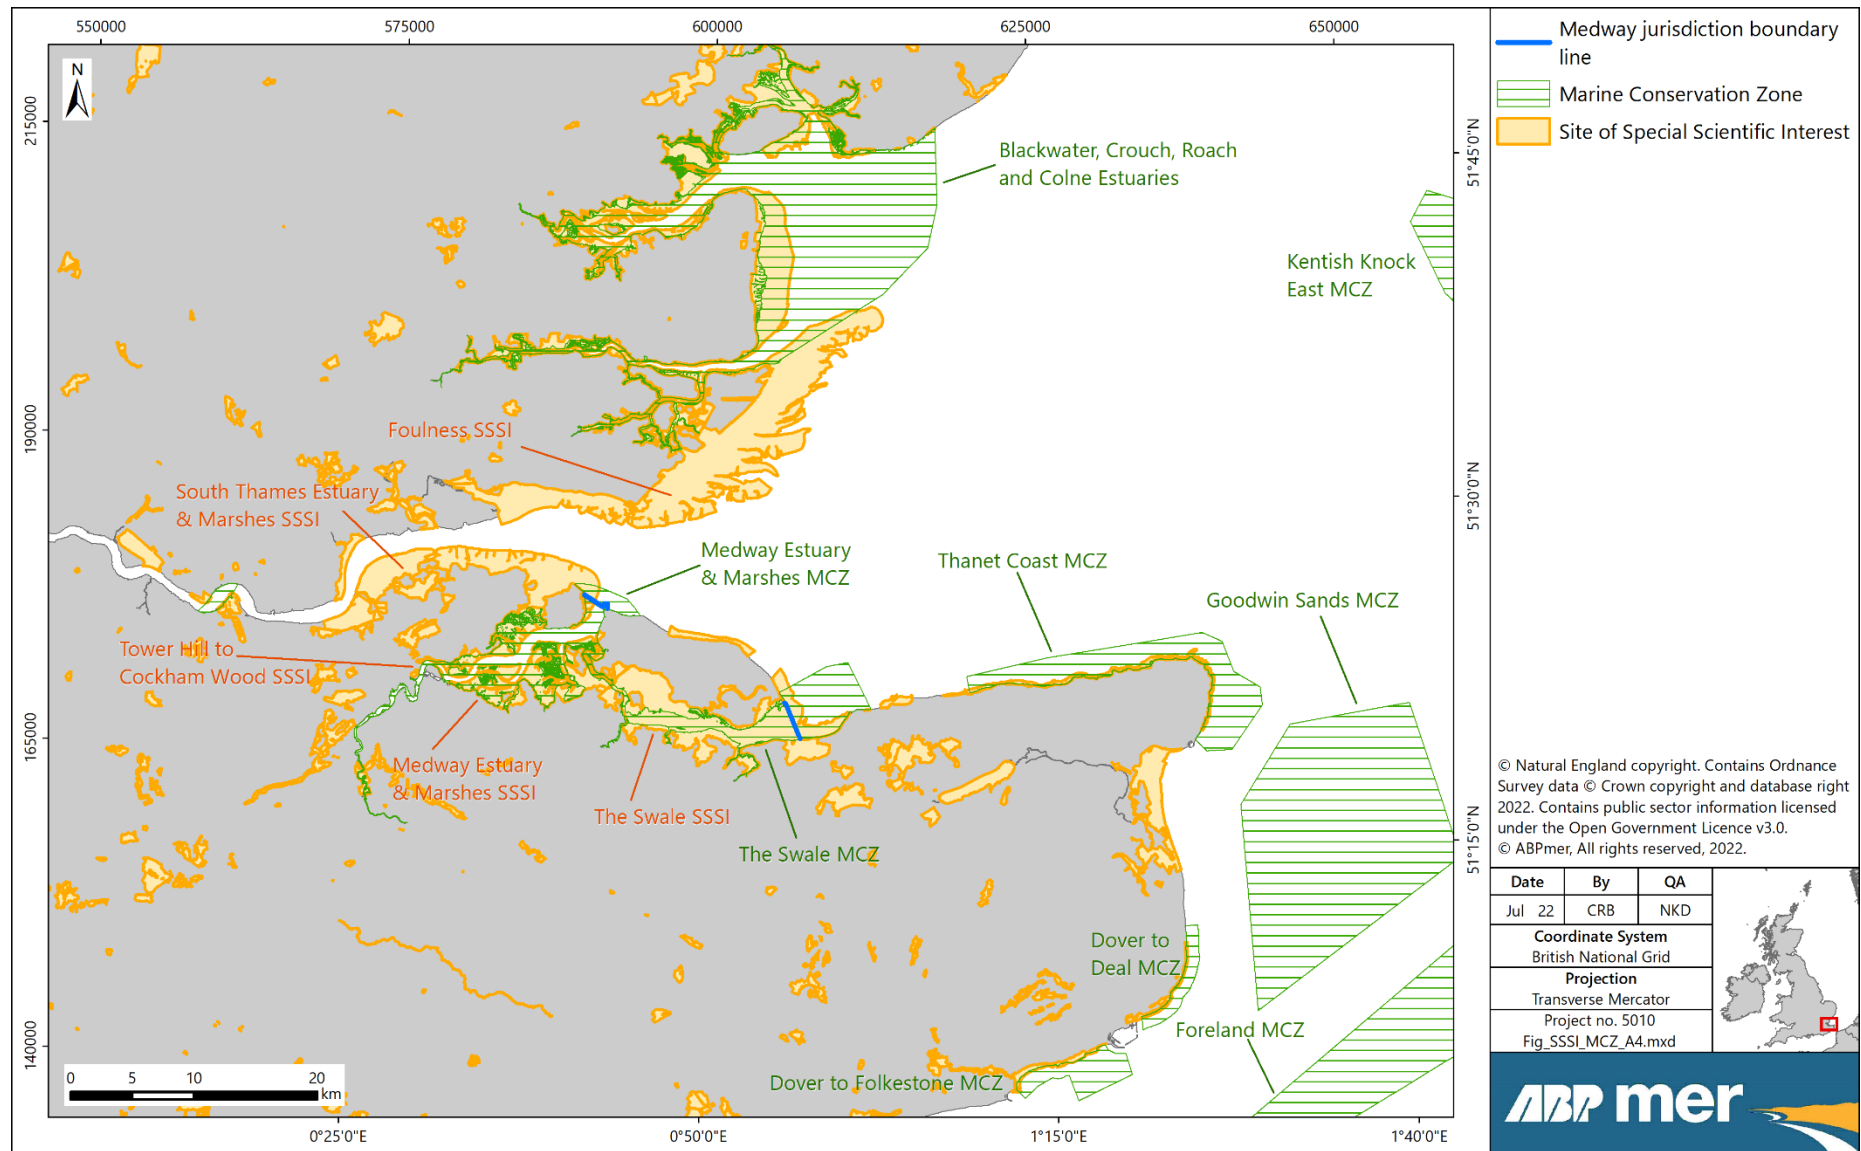
Figure 7.2 SSSIs and MCZs in the study area

The Medway and the surrounding area are of high nature conservation importance, with large areas of the estuary and the adjacent coastline designated as nationally and internationally protected sites. There are currently 14 European/internationally designated sites which overlap or in the vicinity of the maintenance dredge operations and relevant licensed marine disposal sites, including SPAs, SACs and Ramsar sites, as shown in Figure 7.1. SSSIs largely overlap with the intertidal areas of European and international designated sites, and there are also two MCZ within the Medway (Figure 7.2).

The Wildlife and Countryside Act 1981 provides for the designation and management of SSSIs. These sites are designated to safeguard, for present and future generations, the diversity and geographic range of habitats, species, and geological and physiographical features, including the full range of natural and semi-natural ecosystems and of important geological and physiographical phenomena throughout England and Wales. The Countryside and Rights of Way Act 2000 also provides for public access, on foot, to certain types of land; amends the law for public rights of way; increases protection for SSSIs and strengthens wildlife enforcement legislation; and provides for better management of Areas of Outstanding Natural Beauty (AONB). SSSIs within the study area include (see Figure 7.2):

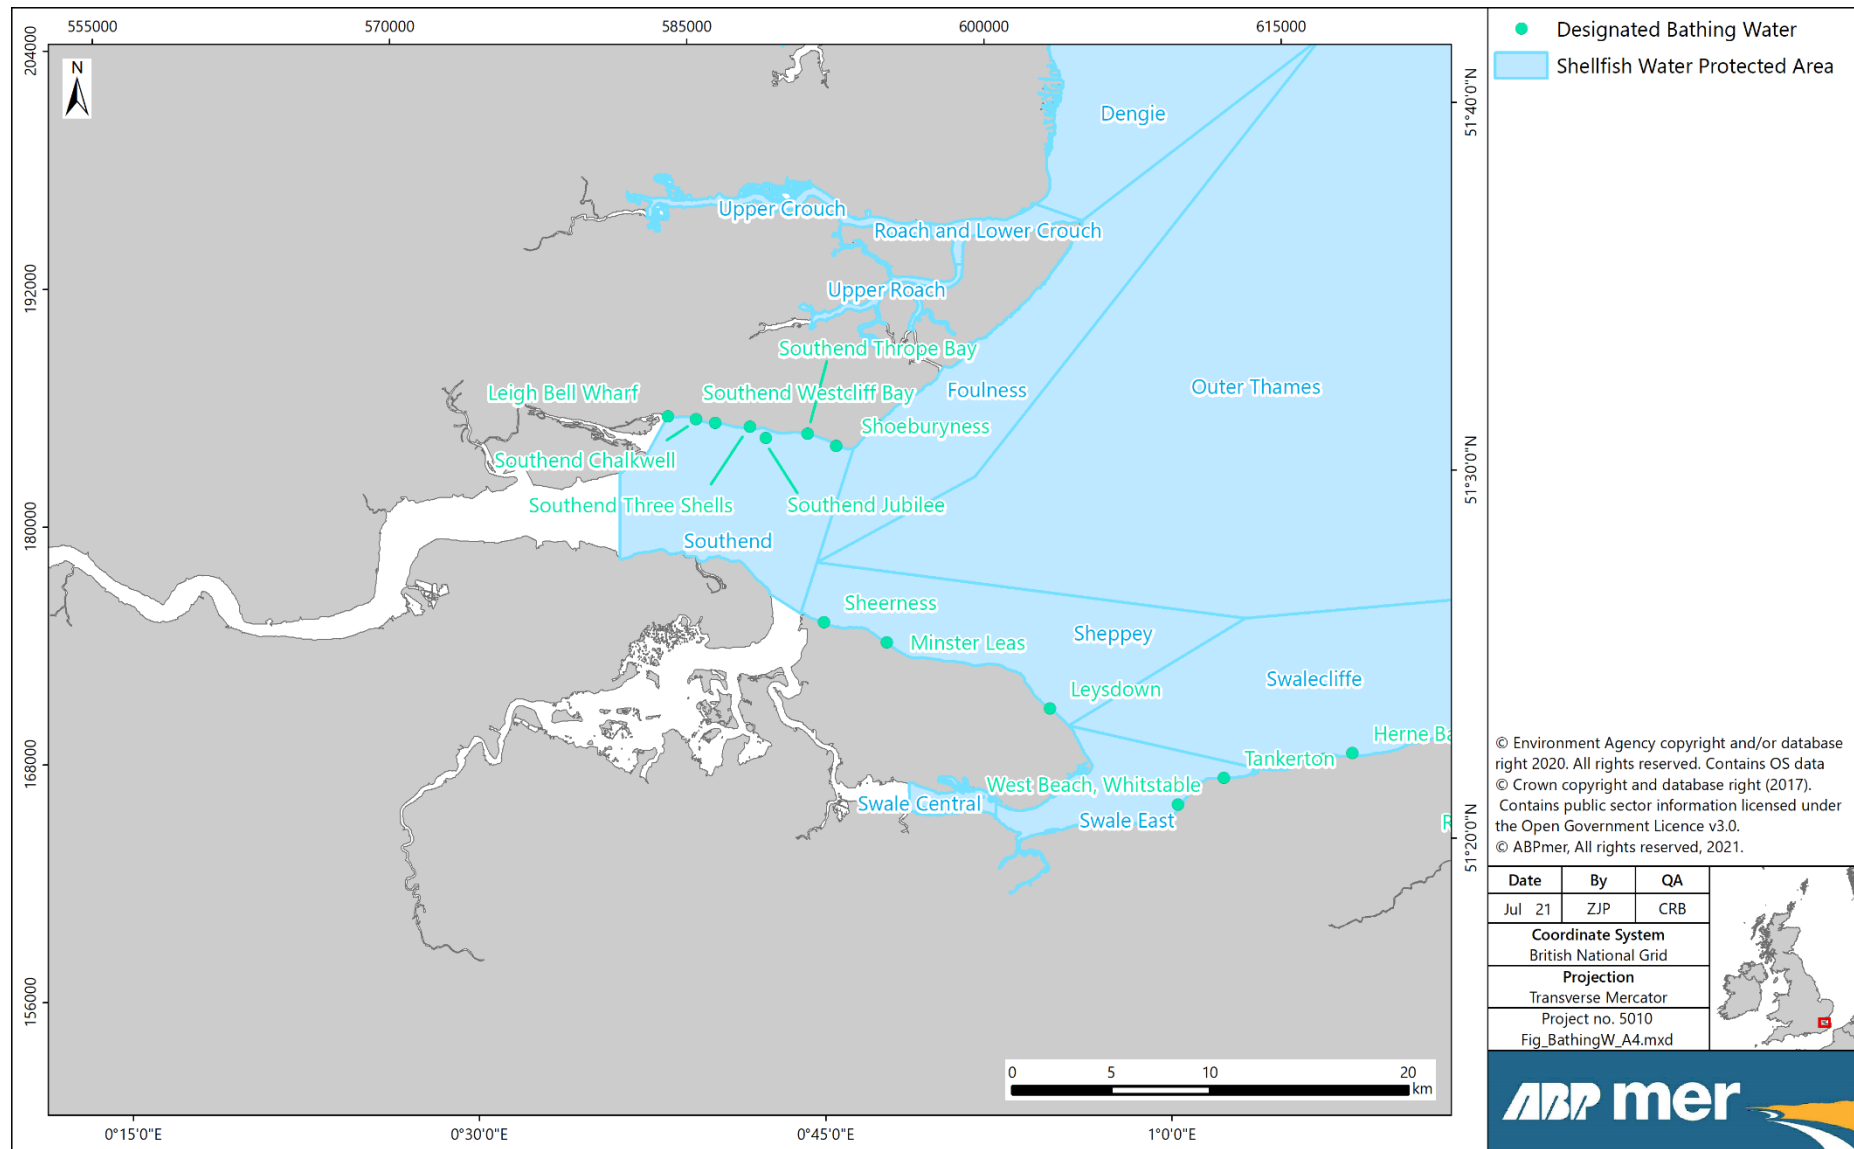
Figure 7.3 Designated bathing waters and Shellfish Water Protected Areas in the study area

There are several Shellfish Water Protected Areas within or in the vicinity of maintenance dredging and disposal activities for the Medway, namely (Defra, 2016; see Figure 7.3):
