Peel Ports Group

Medway Maintenance Dredge Protocol (MDP) Baseline Document

Update

July 2022

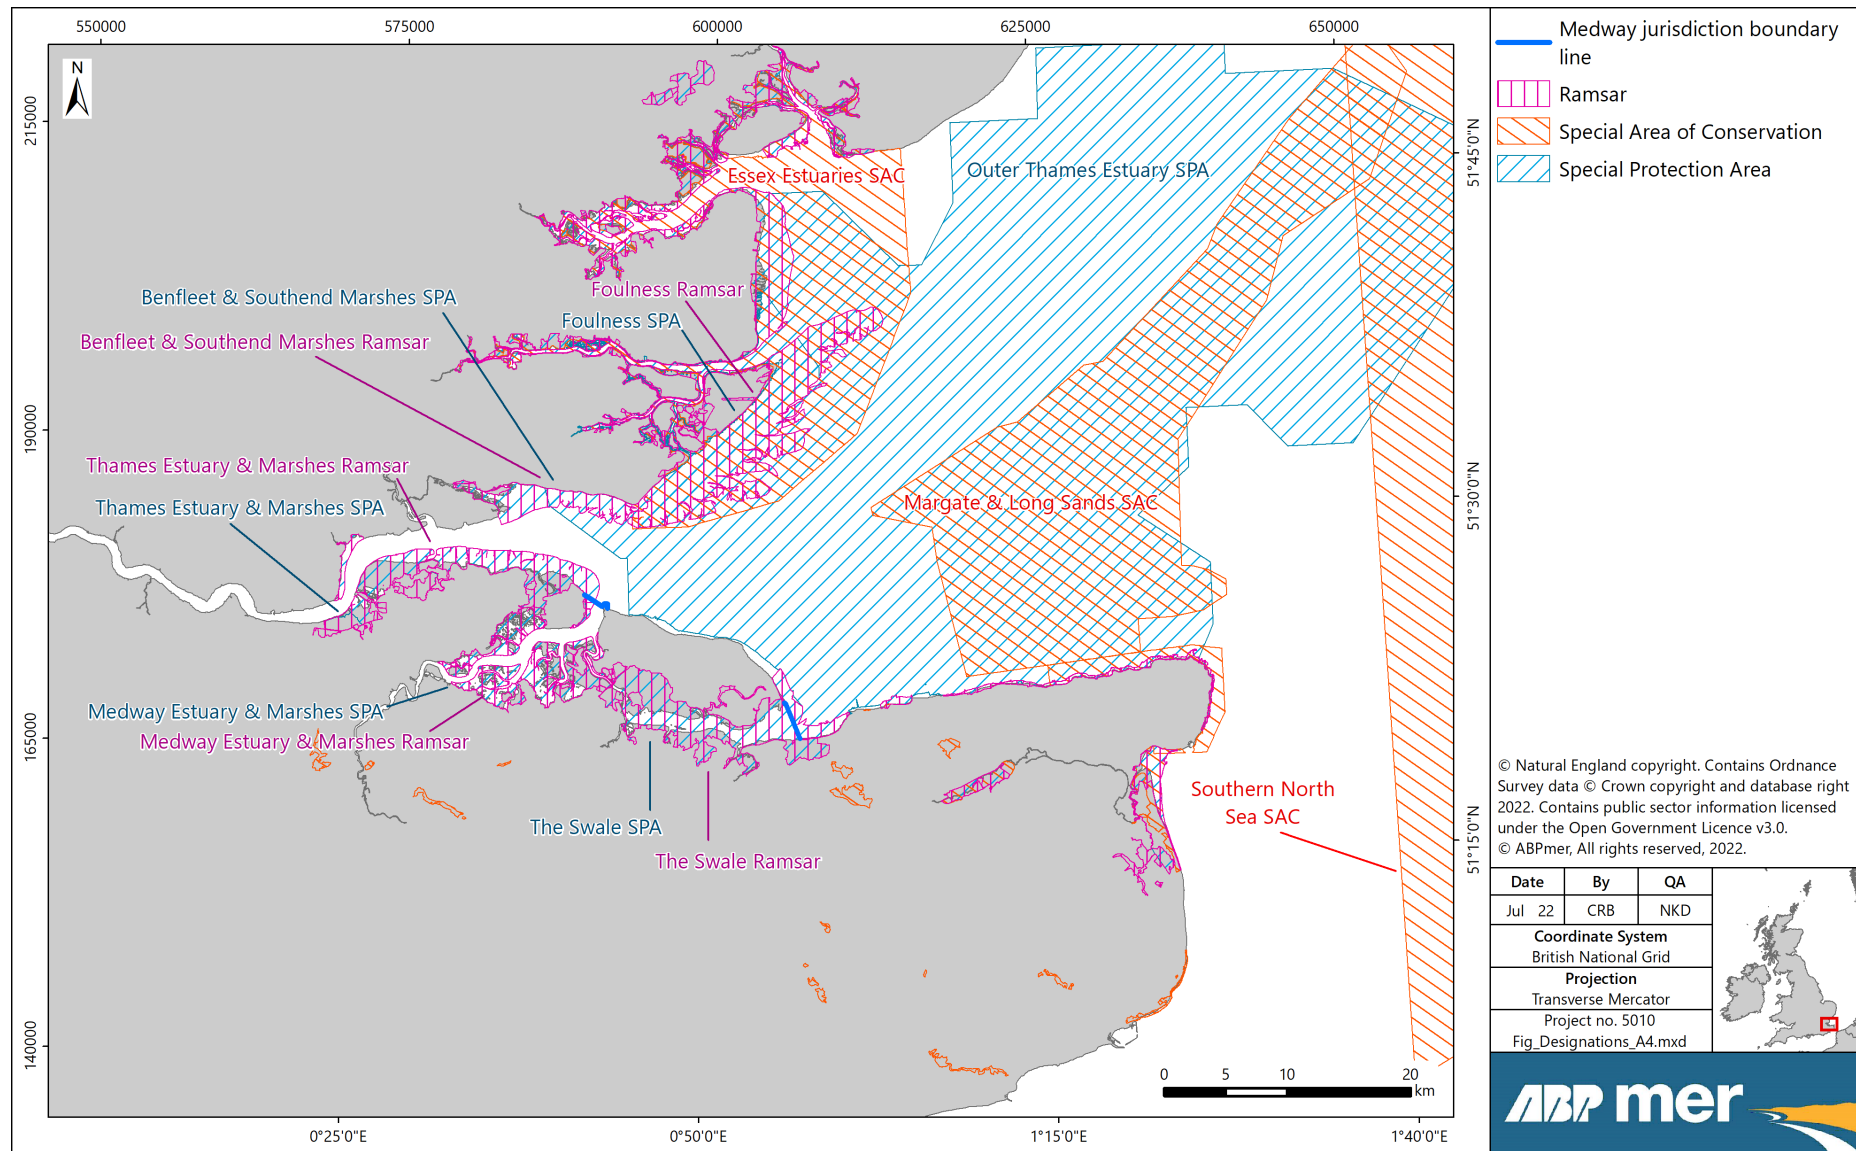
Figure C1. European and international nature conservation designated sites in the study area
