Surveyed by: VO
Processed by: VO
Checked by: NM
Surveyed: 6th February 2023
Issued: 21st February 2023

MERSEY DOCKS AND HARBOUR COMPANY LTD
Gary Doyle
Group Harbour Master
Liverpool Channel

LPC006_2_2023_001
Crosby Channel South

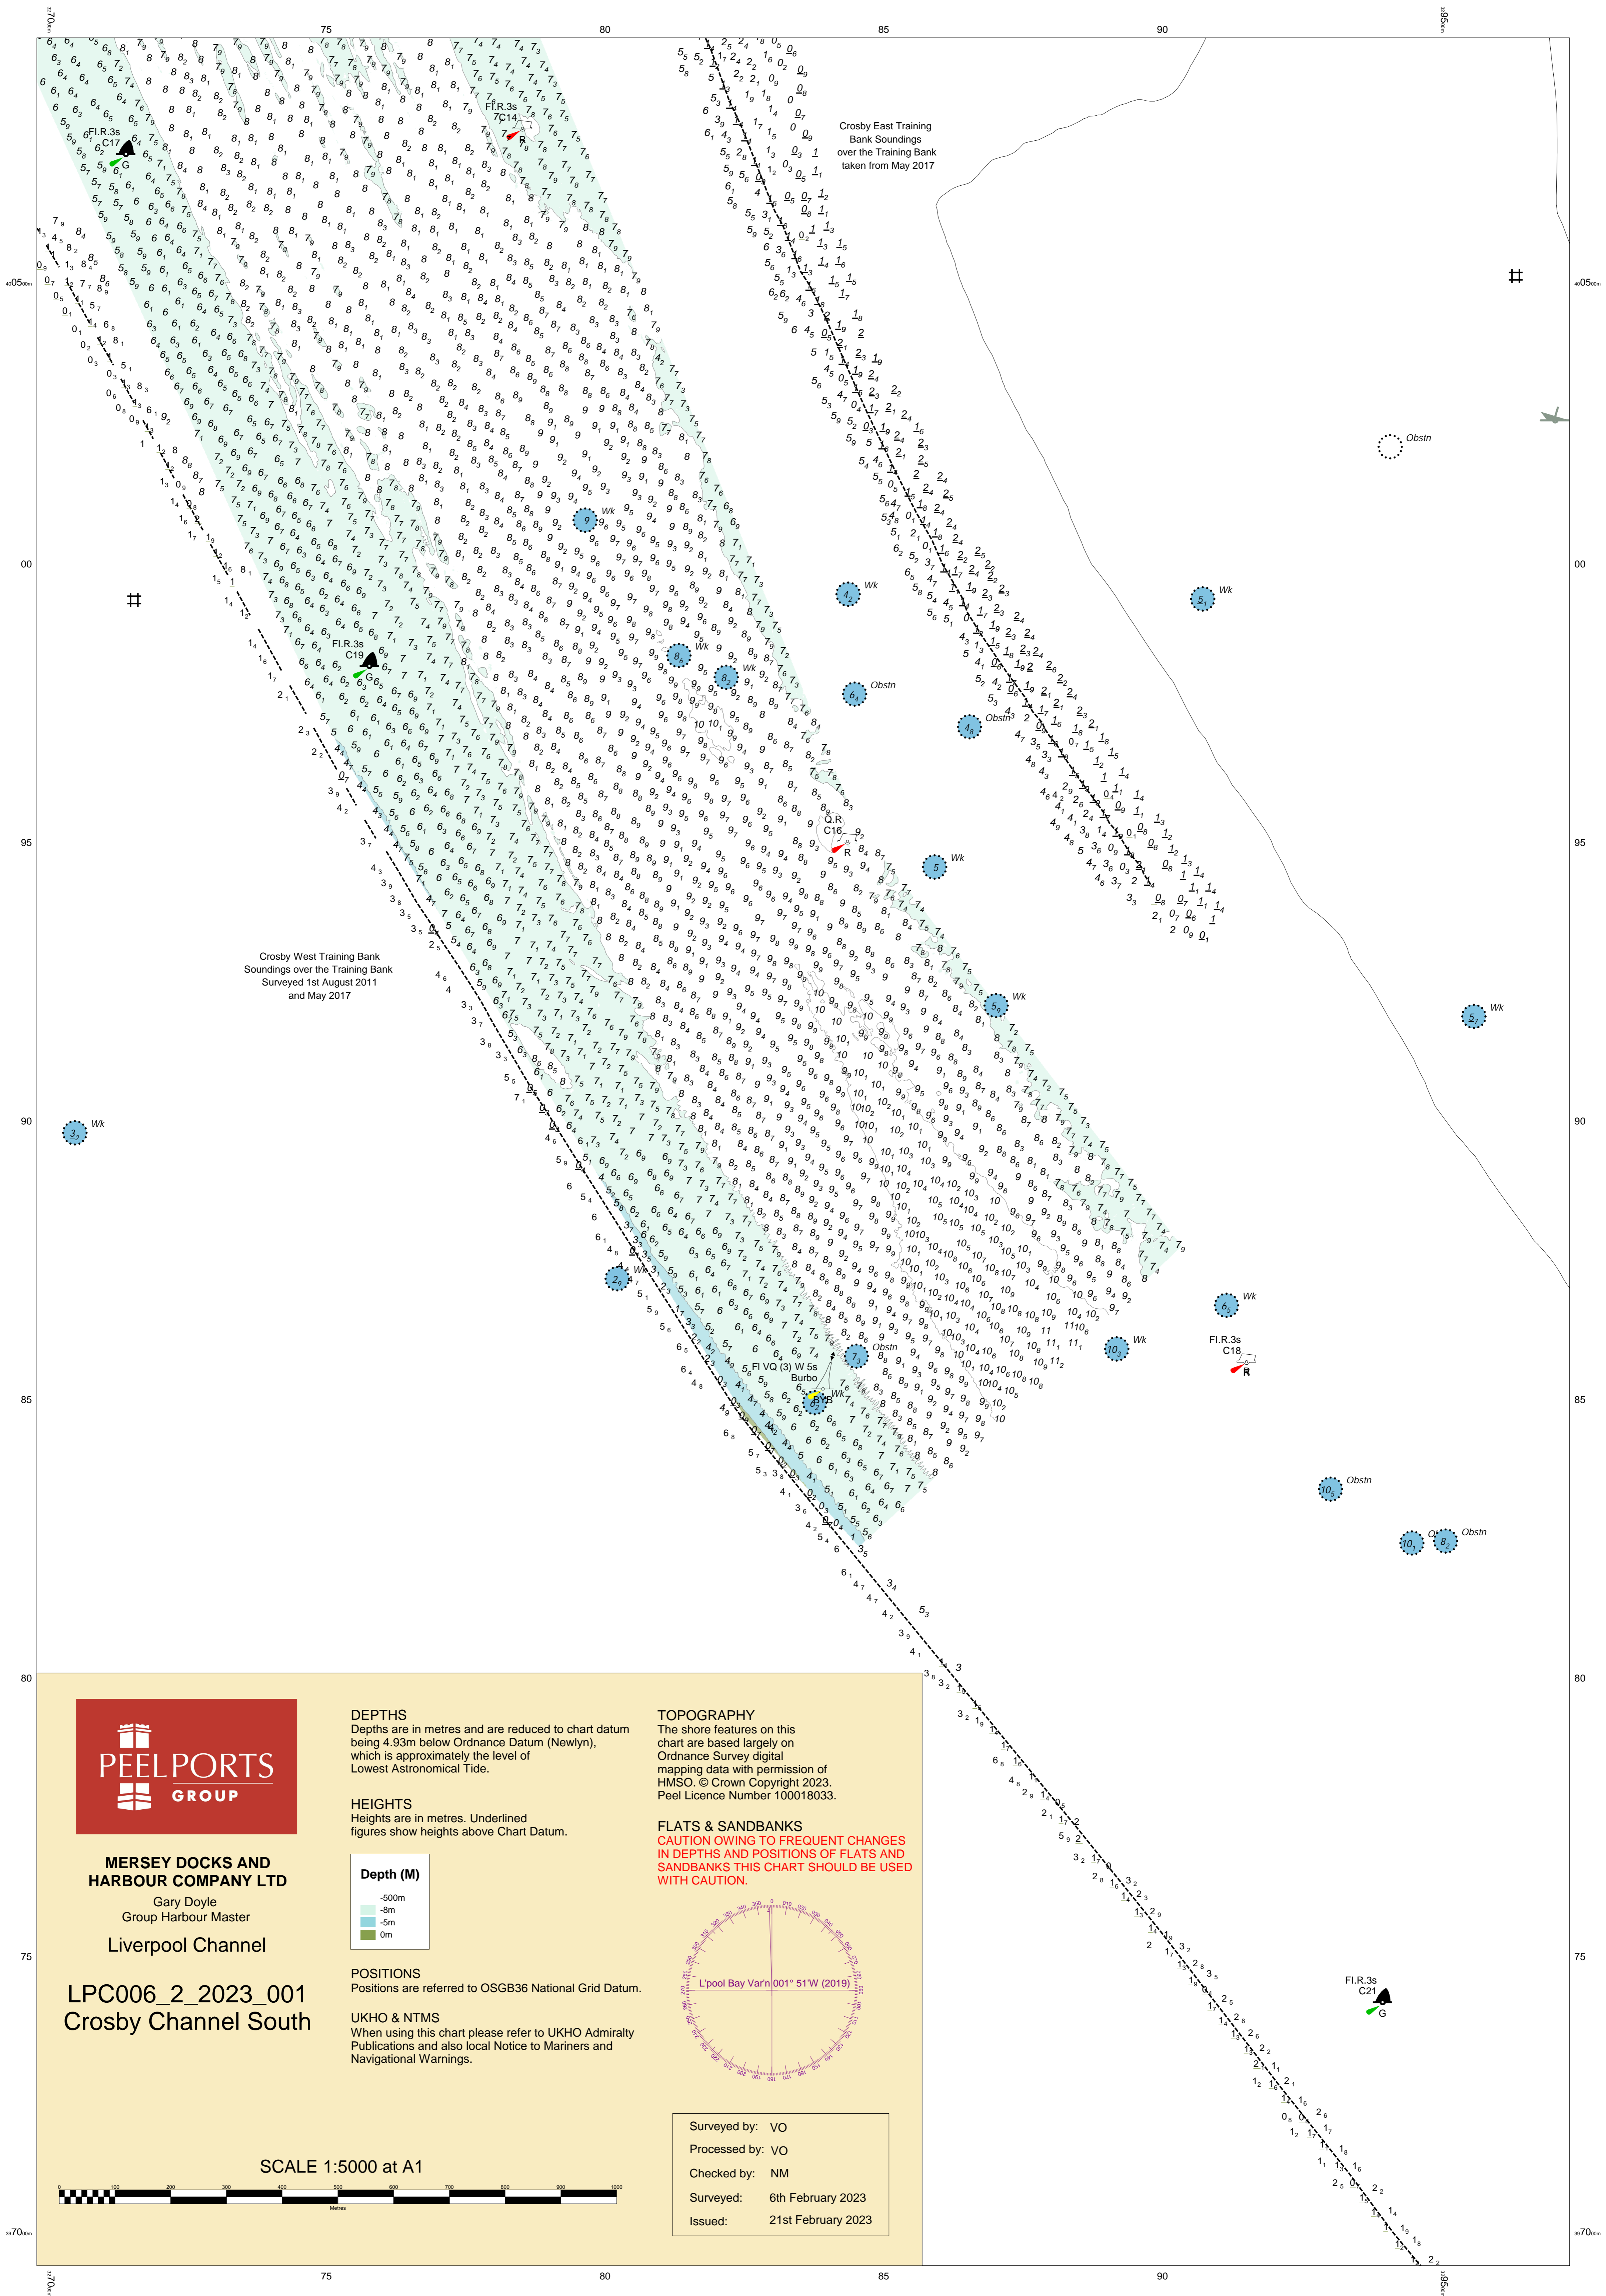
Crosby East Training Bank Soundings over the Training Bank taken from May 2017

Crosby West Training Bank Soundings over the Training Bank Surveyed 1st August 2011 and May 2017

DEPTHS
Depths are in metres and are reduced to chart datum being 4.93m below Ordnance Datum (Newlyn), which is approximately the level of Lowest Astronomical Tide.

HEIGHTS
Heights are in metres. Underlined figures show heights above Chart Datum.
