**MERSEY DOCKS AND HARBOUR COMPANY LTD**  
Captain Susan Cloggie-Holden MNM  
Group Harbour Master

River Mersey

**LPR001\_3\_2025\_010**  
**Langton River Entrance**

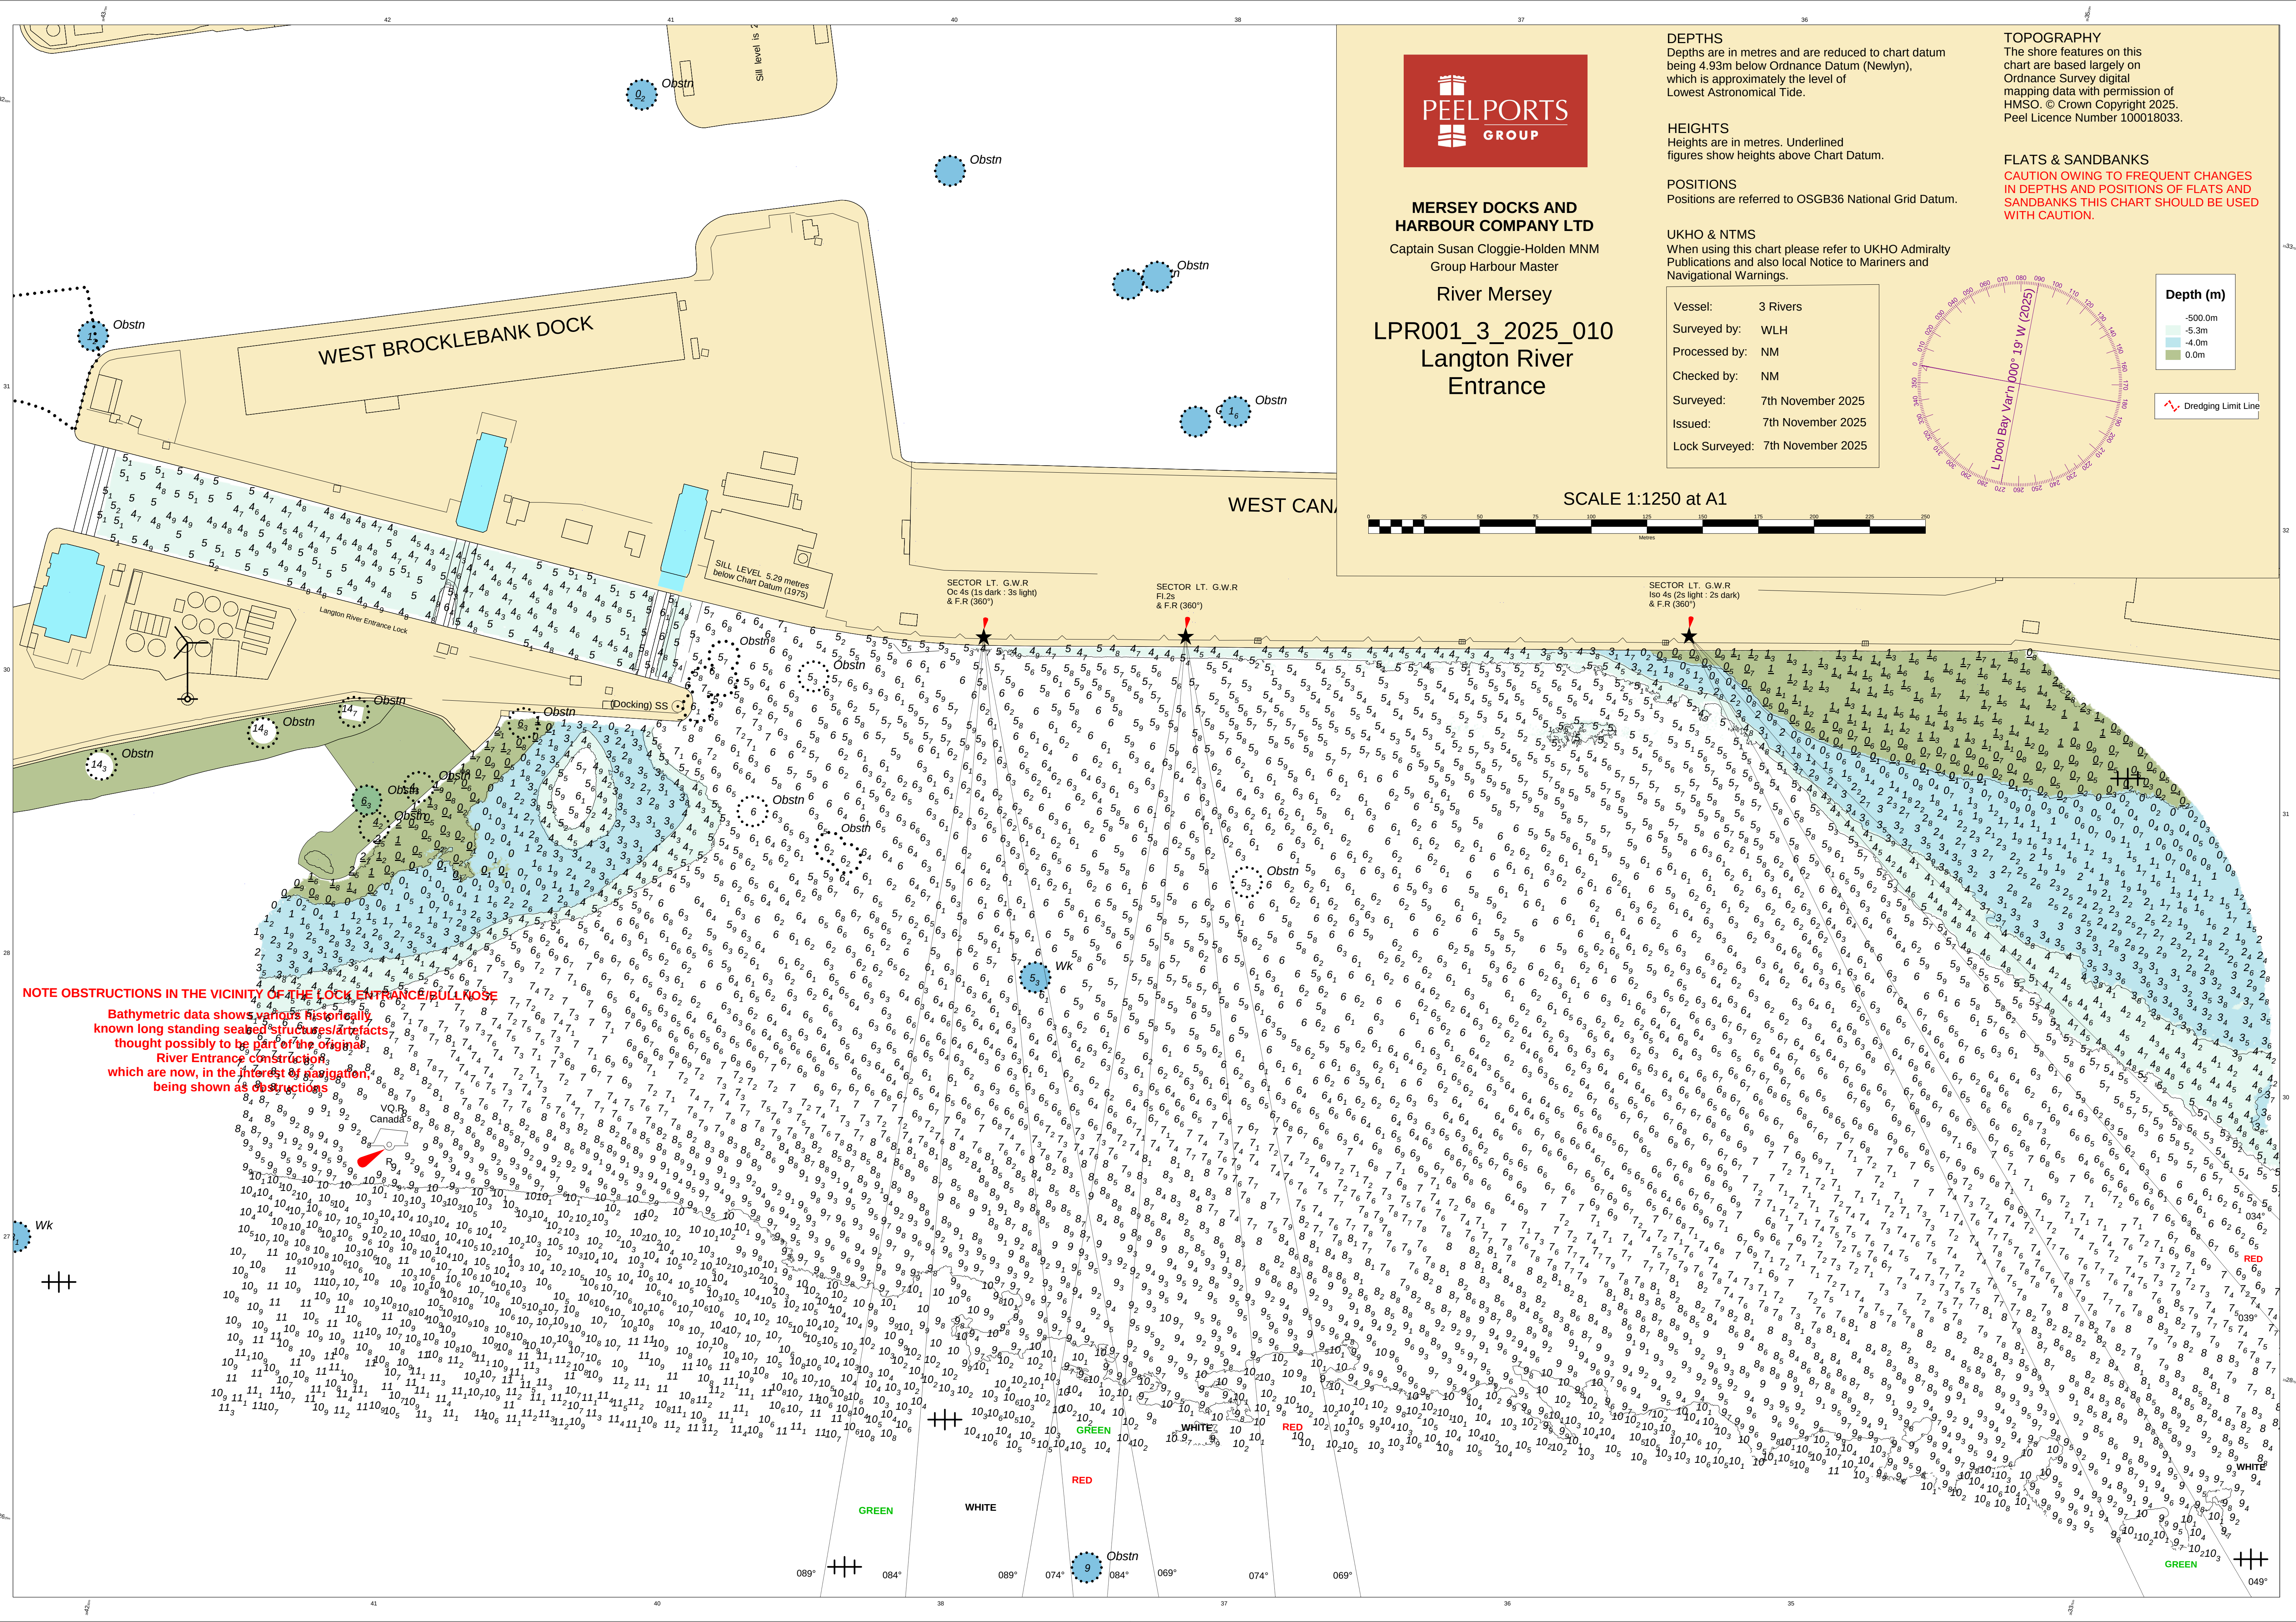
**NOTE OBSTRUCTIONS IN THE VICINITY OF THE LOCK ENTRANCE BULLNOSE**

Bathymetric data shows various historically known long standing sealed structures/artefacts, thought possibly to be part of the original River Entrance construction, which are now, in the interest of navigation, being shown as obstructions
